Home Report

Thirlstane
Lochwinnoch Road
Kilmacolm
PA13 4DU

single survey

Property address	Thirlstane Lochwinnoch Road Kilmacolm PA13 4DU
Customer	Mrs Maureen Pieri
Prepared by	Graham + Sibbald LLP

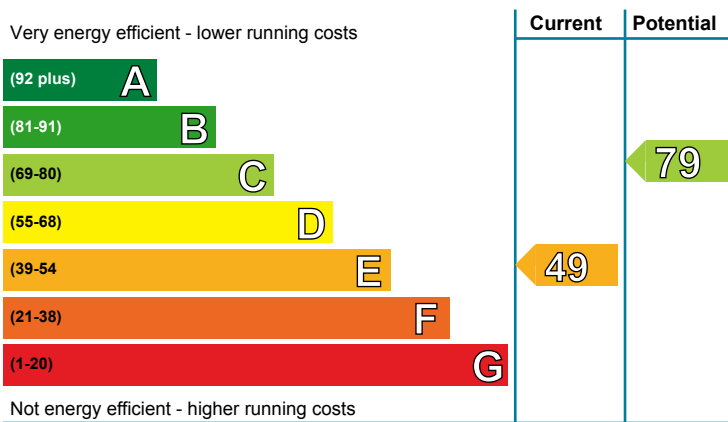
Energy Efficiency Rating

Your current rating is **band E (49)**. The average rating for EPCs in Scotland is **band D (61)**.
