espc:home report

10/8 Chancelot Terrace, Trinity
Edinburgh
EH6 4ST
04/04/2024

Property address	3F2, 10 Chancelot Terrace, Warriston, Edinburgh, EH6 4ST
-------------------------	--

Date of inspection	21st February 2024
---------------------------	--------------------

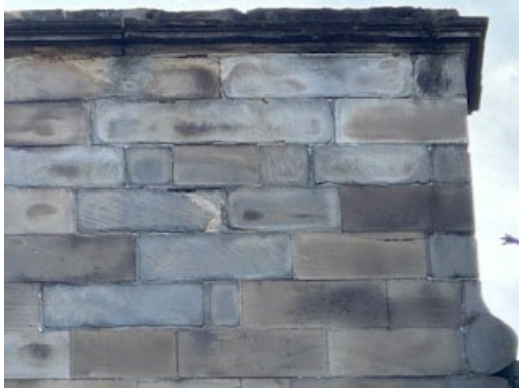
Repair category	2
Notes	Stonework to chimneys is weathered, pointing is open and pots are damaged/off level/missing. A reputable contractor will be able to advise further.

Weathered stone and pointing
(front elevation chimney)

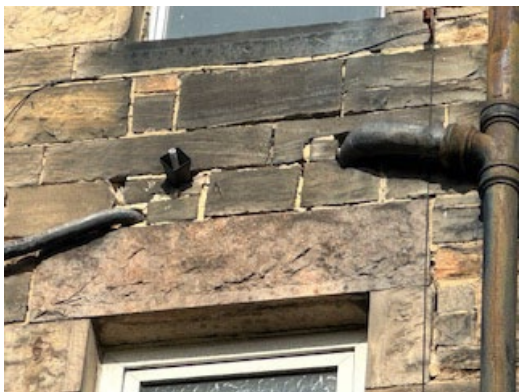
Repair category	2
Notes	Pointing to walls is open, stonework is weathered and mastic to window surrounds is cracked. A builder will be able to advise further.

Pointing rear elevation in need of
attention

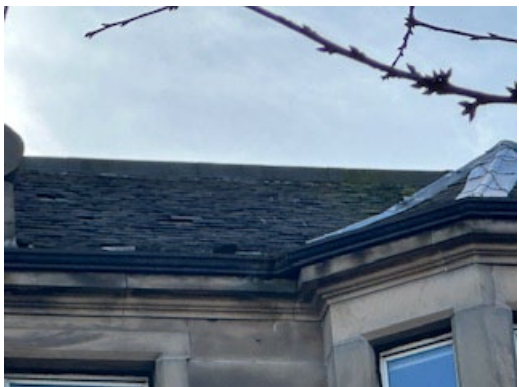
Repair category	2
Notes	<p>There are a number of lifted, loose and damaged slates. Natural slates have an expected lifespan of up to 100 years or more depending on slate quality, source, thickness and cutting skill of the slate. Slates will deteriorate over time; nail fixings will corrode and loosen resulting in on-going maintenance requirements. Close quarter and disruptive inspections may reveal damage to roofing materials, especially where these are original. Regular maintenance should be anticipated particularly after adverse weather conditions.</p> <p>The flat bitumen felt has a limited life expectancy and can fail without warning. Inspection at close quarters may reveal further deterioration/damage to roofing materials, especially where these are original. A reputable roofing contractor will</p>

Slipped slates

Repair category	2
Notes	be able to provide further advice.

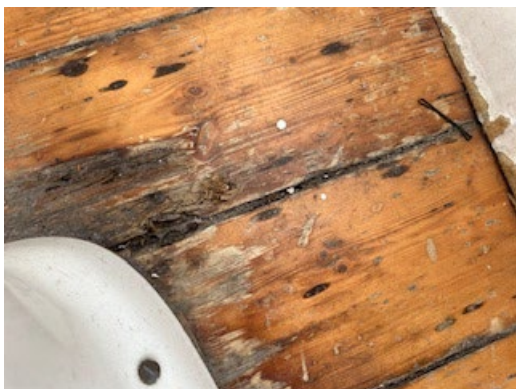
- Softened and part decayed flooring timbers below and adjacent to the WC, which may have been caused by general spillage, although prior attention to sealant around the bath suggesting possible water ingress below.
- The top side of the joists within the window recess rear right tested dry.

Softened flooring timbers below and adjacent to the wc

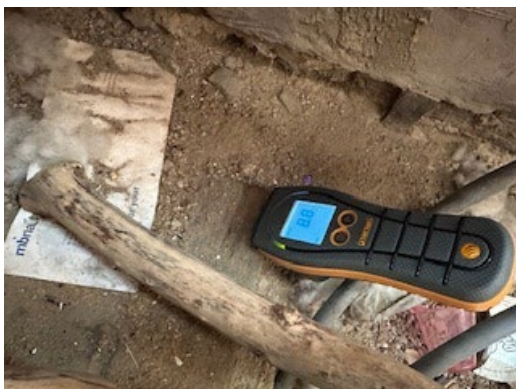
The top of floor joists to rear where accessible tested dry at time of survey

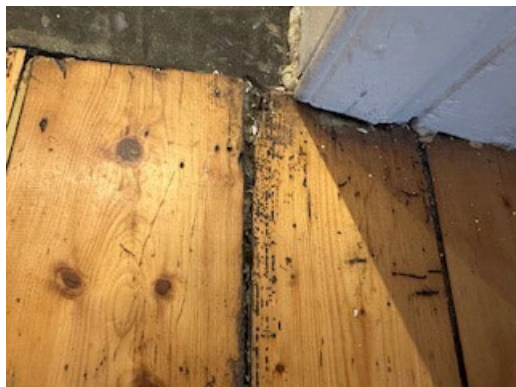
Signs of common furniture beetle attack in sanded and sealed floor timbers
