# espc:home report

15/2 Douglas Crescent, West End  
Edinburgh  
EH12 5BA  
22/02/2024

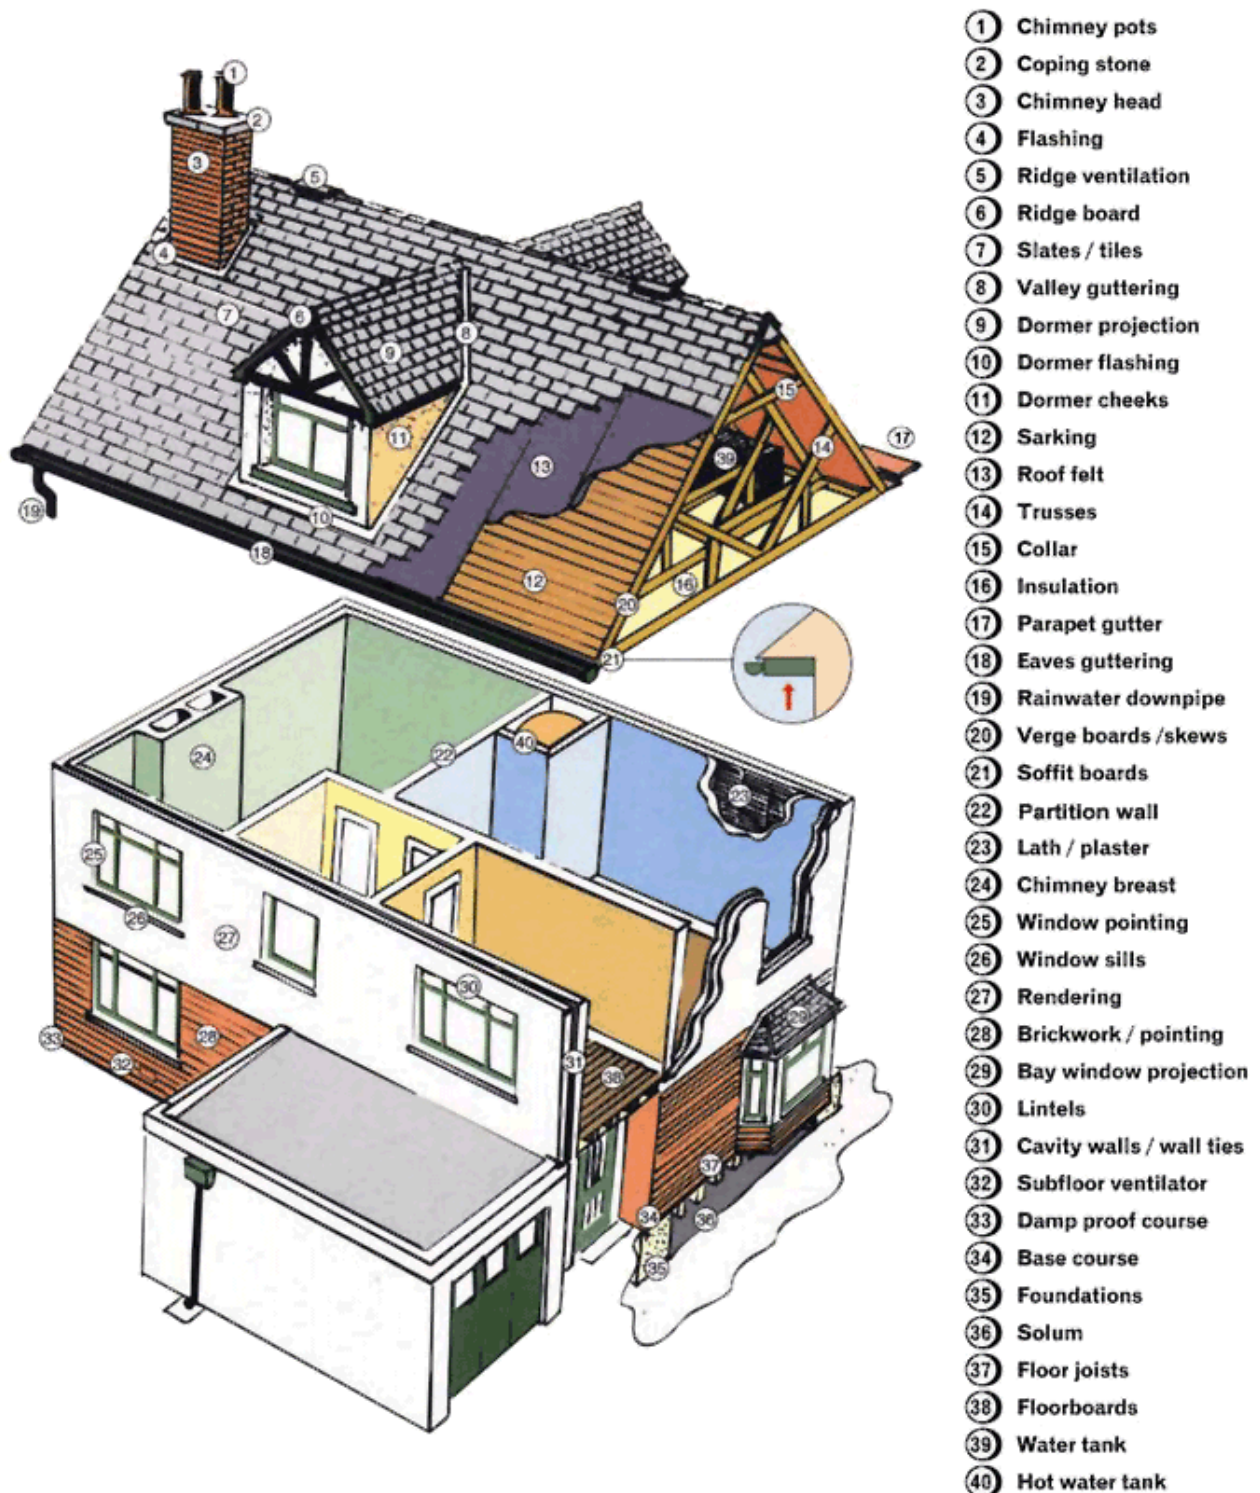
Reference may be made in this report to some or all of the above component parts of the property. This diagram may assist you in locating and understanding these items.

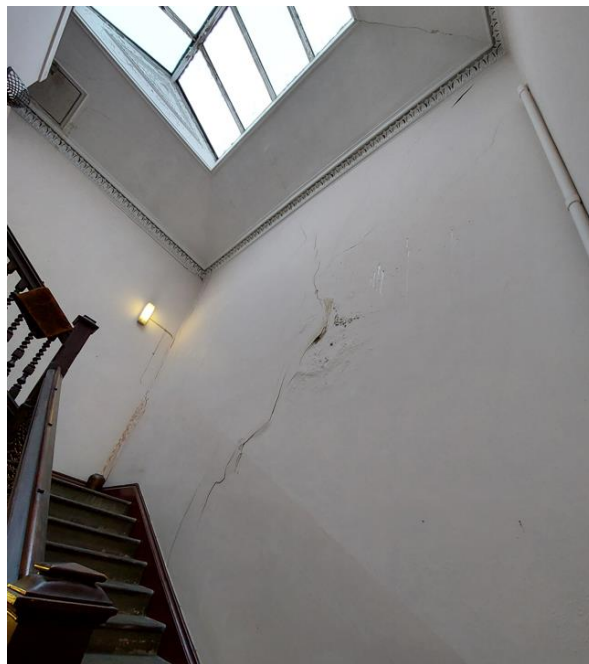
*Figure 1: Site Photo of cracking to party wall at 2<sup>nd</sup> floor level*

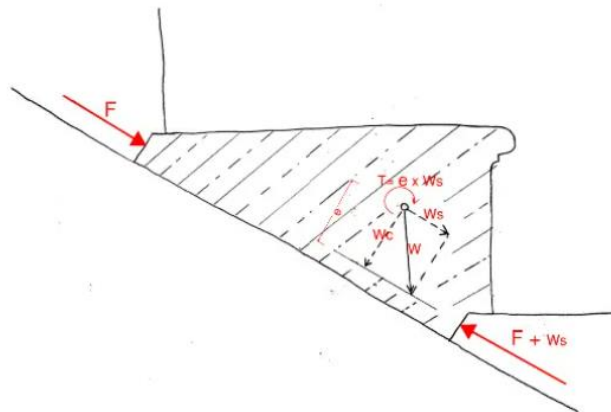
*Figure 2: Forces in stone cantilever stair treads*

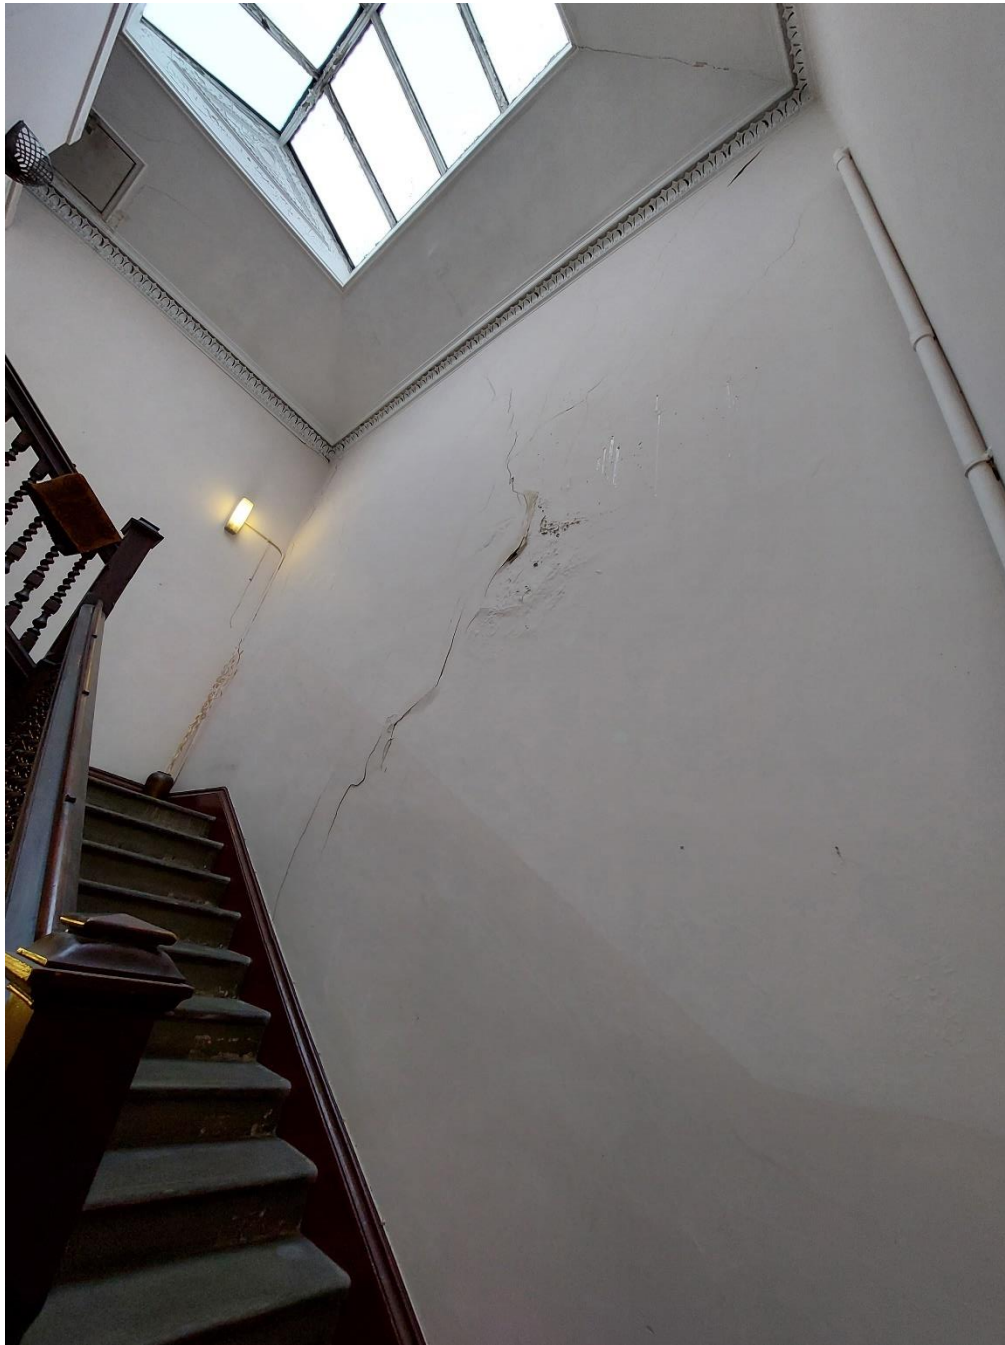
*Photo 1: Main cracking to party wall*

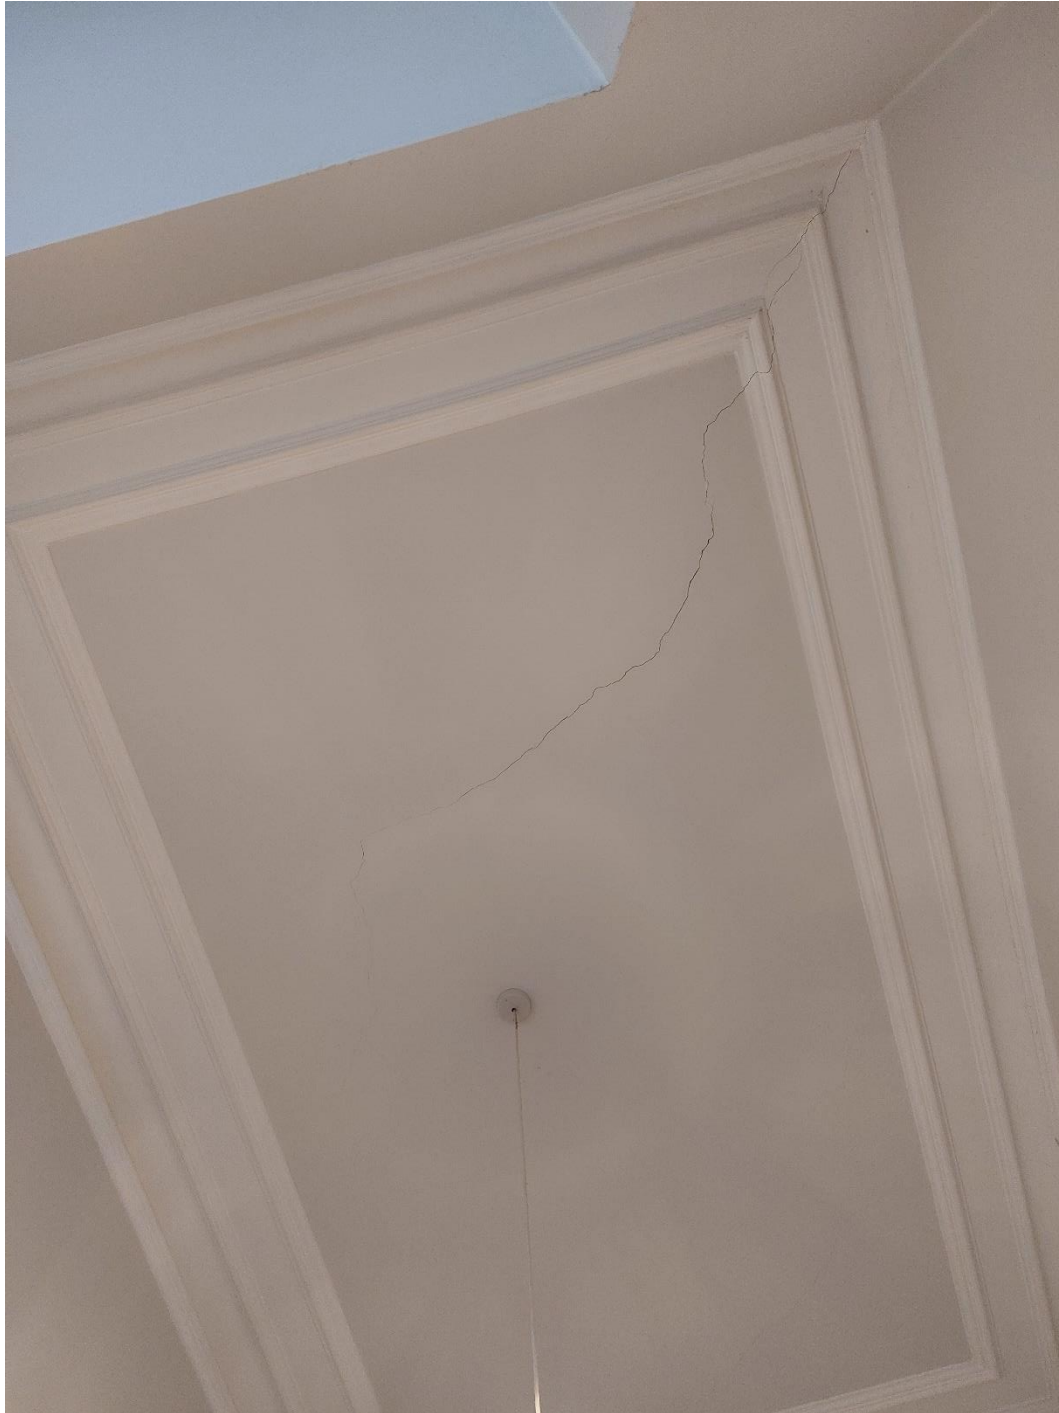
*Photo 2: Example of crack to internal ceiling finishes*

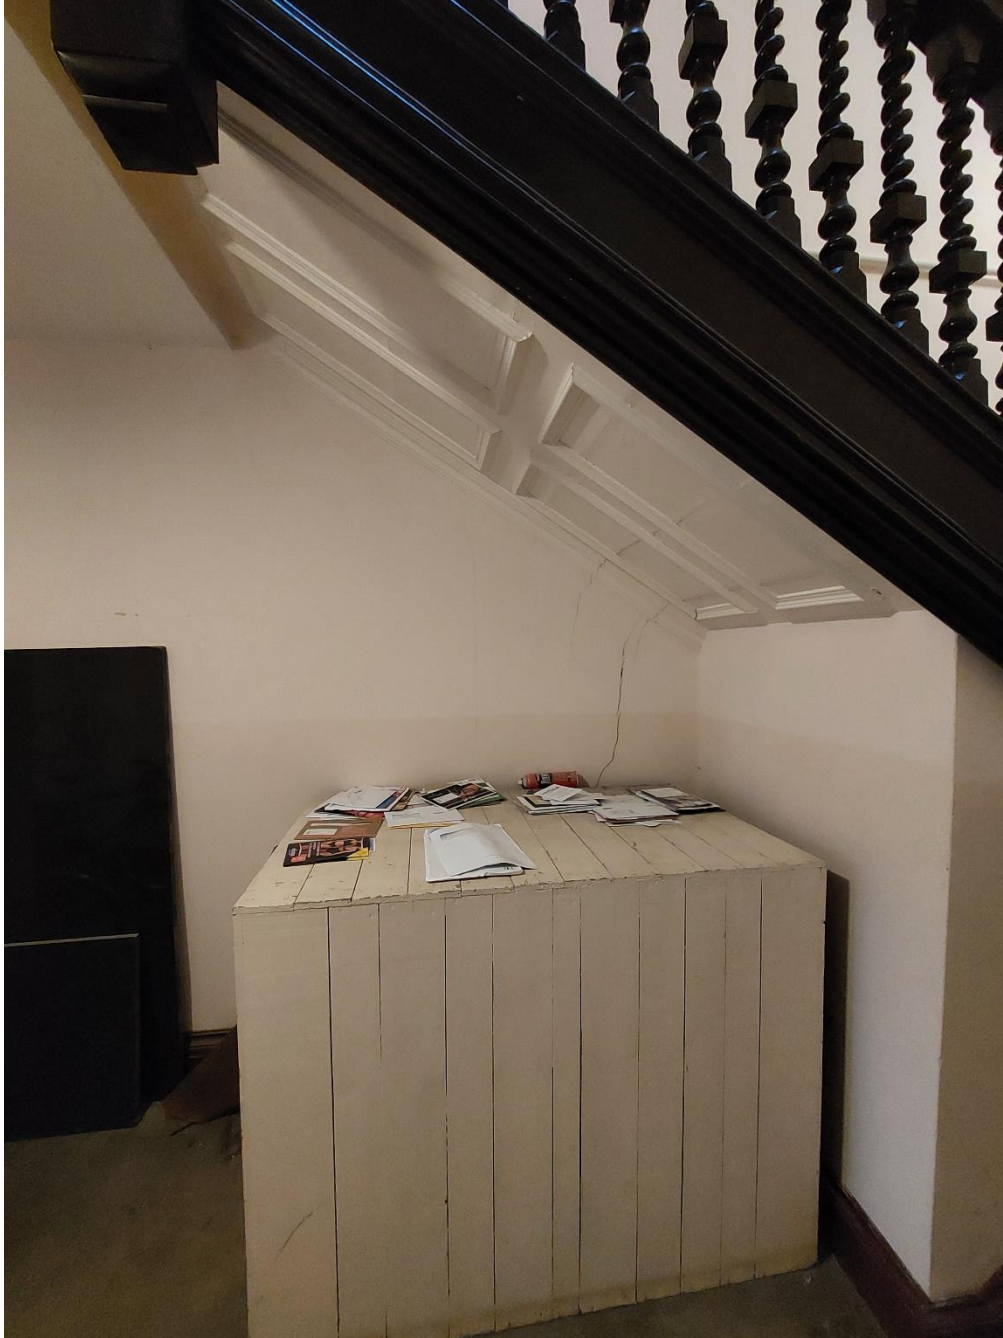
*Photo 3: Minor cracking to ground floor party wall and cantilever stair*

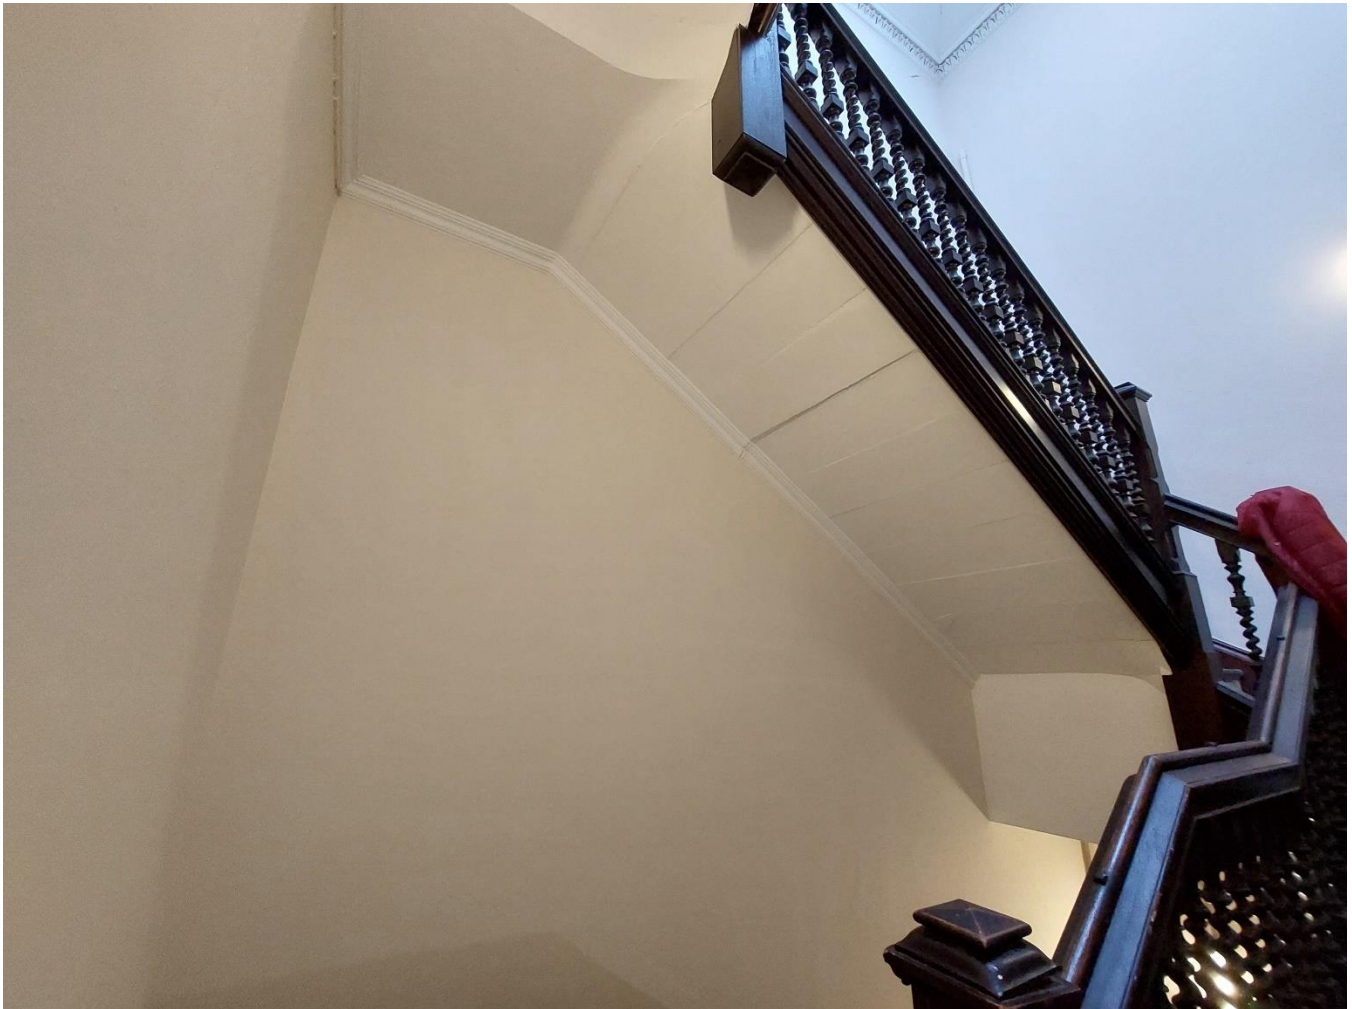
*Photo 4: No cracking present to first floor wall and no reoccurring cracking to stone stair treads*

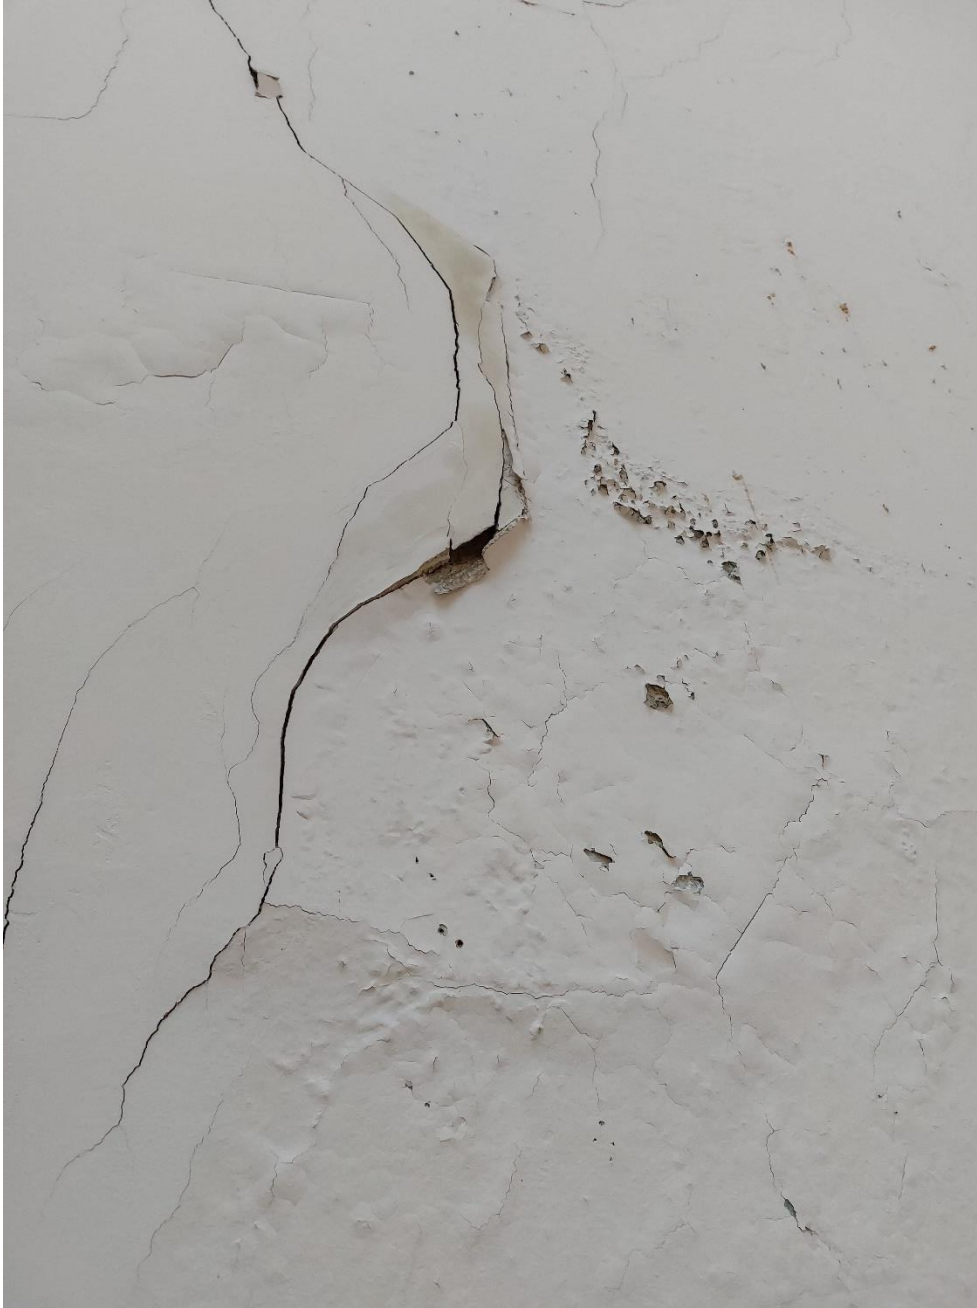
*Photo 5: Clear signs of moisture/damp to worst section of cracking*

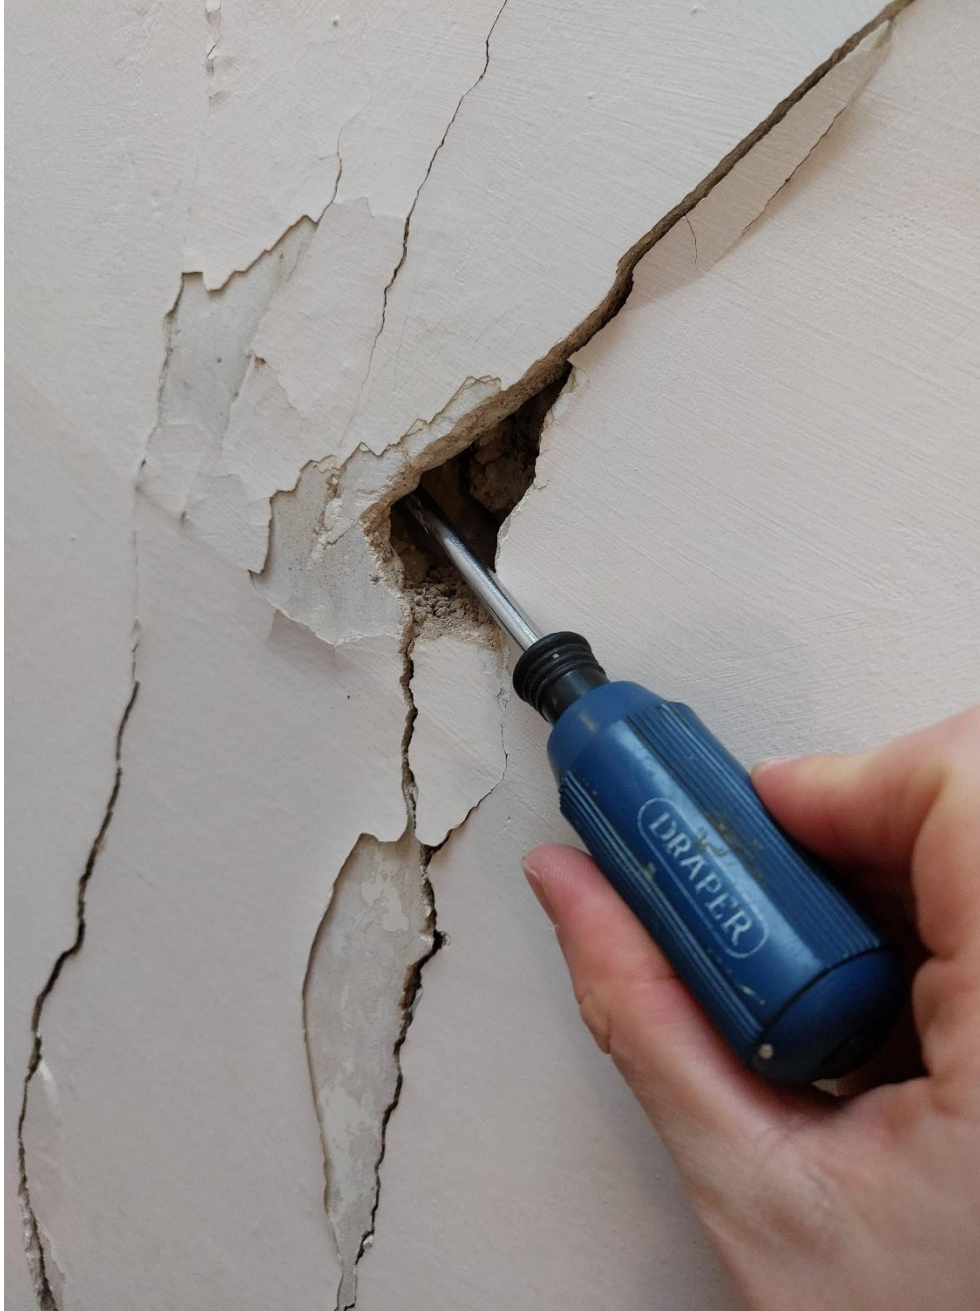
*Photo 6: Plaster has delaminated from masonry behind locally at the bulge in the crack. Cracking did not appear to extend into masonry behind on probing*
