espc:home report

32 Silverknowes Grove, Silverknowes
Edinburgh
EH4 5NH
25/04/2024

Home Report Index

Single Survey

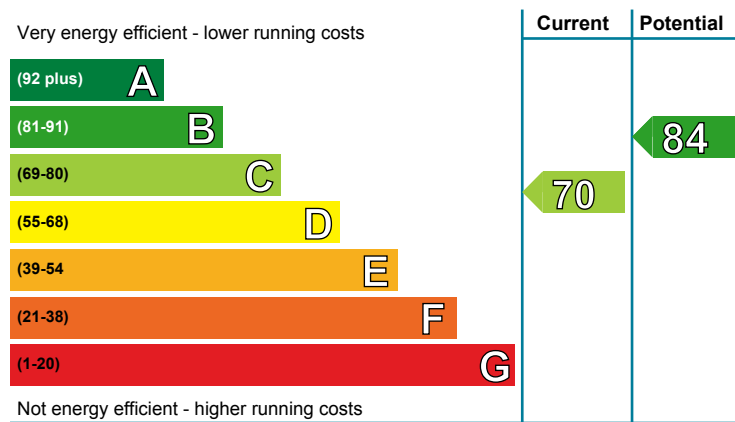
Energy Efficiency Rating

This graph shows the current efficiency of your home, taking into account both energy efficiency and fuel costs. The higher this rating, the lower your fuel bills are likely to be.

Your current rating is **band C (70)**. The average rating for EPCs in Scotland is **band D (61)**.

The potential rating shows the effect of undertaking all of the improvement measures listed within your recommendations report.

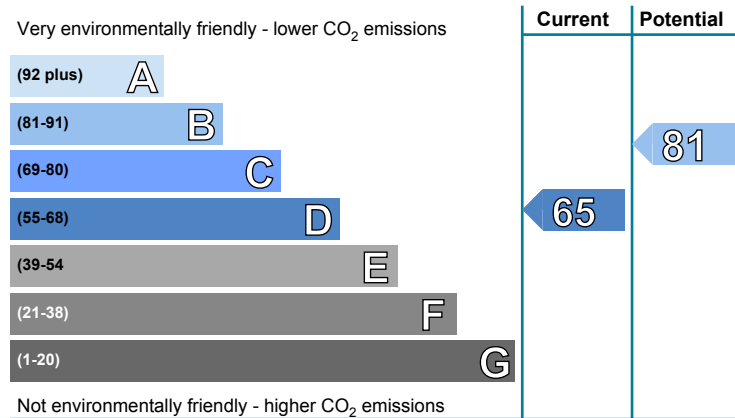
Environmental Impact (CO₂) Rating

This graph shows the effect of your home on the environment in terms of carbon dioxide (CO₂) emissions. The higher the rating, the less impact it has on the environment.
