espc:home report

Home Report Index

SINGLE SURVEY REPORT

**8/1 PICARDY PLACE
EDINBURGH
EH1 3JT**

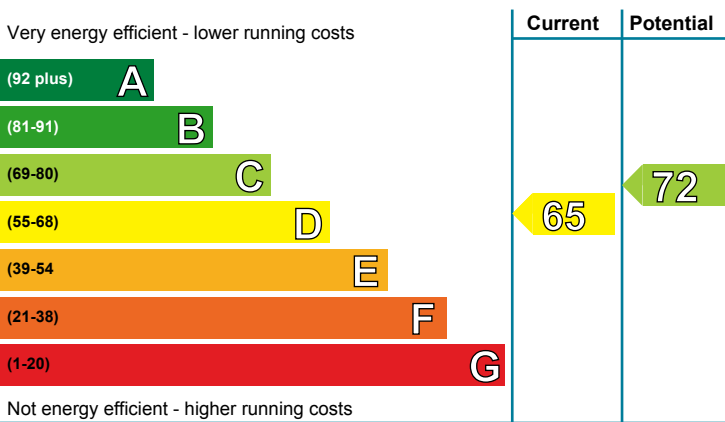
Energy Efficiency Rating

This graph shows the current efficiency of your home, taking into account both energy efficiency and fuel costs. The higher this rating, the lower your fuel bills are likely to be.

Your current rating is **band D (65)**. The average rating for EPCs in Scotland is **band D (61)**.

The potential rating shows the effect of undertaking all of the improvement measures listed within your recommendations report.
