Home Report

Scottish Single Survey

Property address	57 Tannahill Crescent Johnstone PA5 0ES
-------------------------	---

Prepared by	Shepherd Chartered Surveyors
--------------------	------------------------------

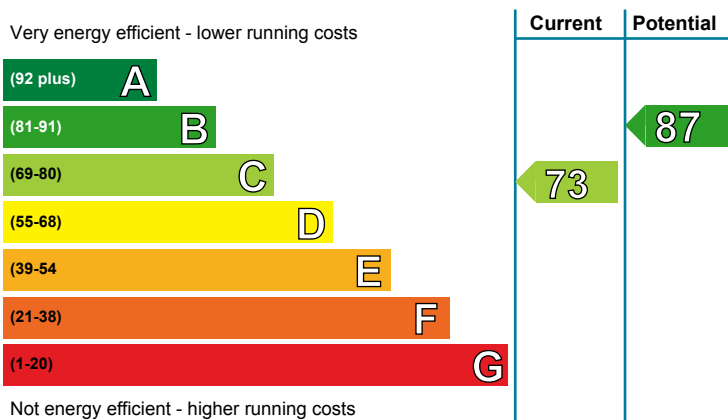
Energy Efficiency Rating

This graph shows the current efficiency of your home, taking into account both energy efficiency and fuel costs. The higher this rating, the lower your fuel bills are likely to be.

Your current rating is **band C (73)**. The average rating for EPCs in Scotland is **band D (61)**.

The potential rating shows the effect of undertaking all of the improvement measures listed within your recommendations report.

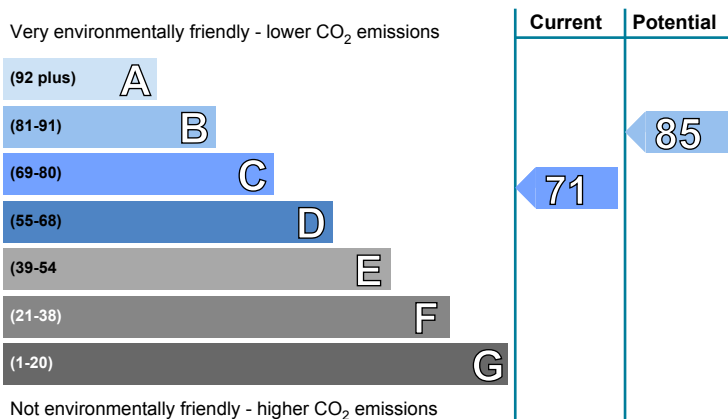
Environmental Impact (CO₂) Rating

This graph shows the effect of your home on the environment in terms of carbon dioxide (CO₂) emissions. The higher the rating, the less impact it has on the environment.
