Home Report Index

Single Survey

Property address	12 Dreghorn Loan, Redford, Edinburgh, EH13 0DE
-------------------------	---

Prepared by	ALLIED SURVEYORS SCOTLAND PLC
--------------------	-------------------------------

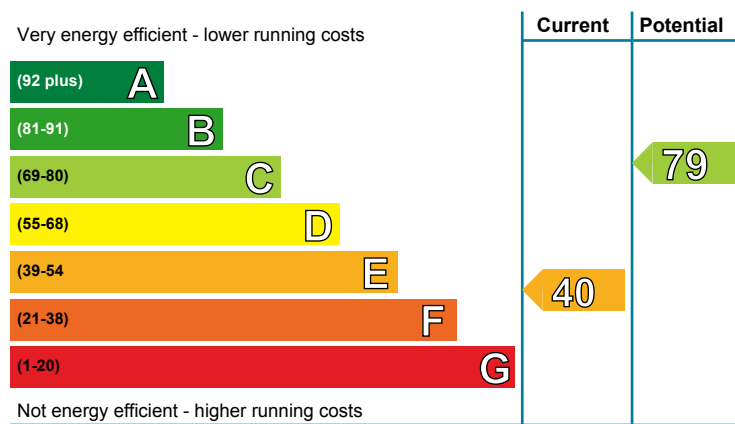
Energy Efficiency Rating

This graph shows the current efficiency of your home, taking into account both energy efficiency and fuel costs. The higher this rating, the lower your fuel bills are likely to be.

Your current rating is **band E (40)**. The average rating for EPCs in Scotland is **band D (61)**.

The potential rating shows the effect of undertaking all of the improvement measures listed within your recommendations report.

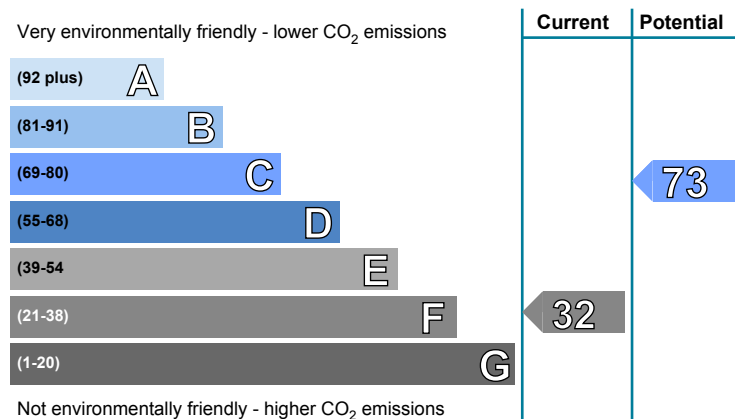
Environmental Impact (CO₂) Rating

This graph shows the effect of your home on the environment in terms of carbon dioxide (CO₂) emissions. The higher the rating, the less impact it has on the environment.

The potential rating shows the effect of undertaking all of the improvement measures listed within your recommendations report.
