Single Survey

survey report on:

| Property address | 2F, 9 Westhall Gardens, Bruntsfield, Edinburgh, EH10 4JJ |

| Prepared by | J & E Shepherd |

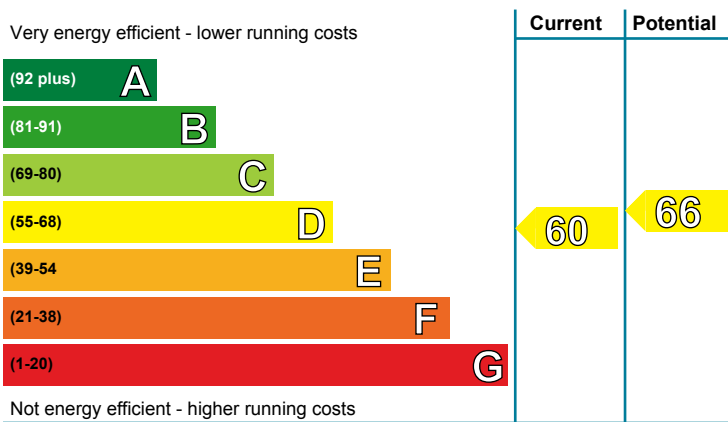
Energy Efficiency Rating

This graph shows the current efficiency of your home, taking into account both energy efficiency and fuel costs. The higher this rating, the lower your fuel bills are likely to be.

Your current rating is **band D (60)**. The average rating for EPCs in Scotland is **band D (61)**.

The potential rating shows the effect of undertaking all of the improvement measures listed within your recommendations report.

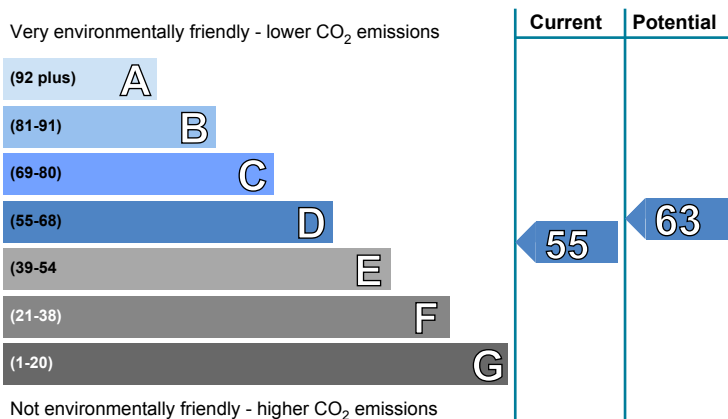
Environmental Impact (CO₂) Rating

This graph shows the effect of your home on the environment in terms of carbon dioxide (CO₂) emissions. The higher the rating, the less impact it has on the environment.
