Home Report Index

Single Survey

Property address	Flat 4, 1 Leamington Terrace, Viewforth, Edinburgh, EH10 4JW
-------------------------	--

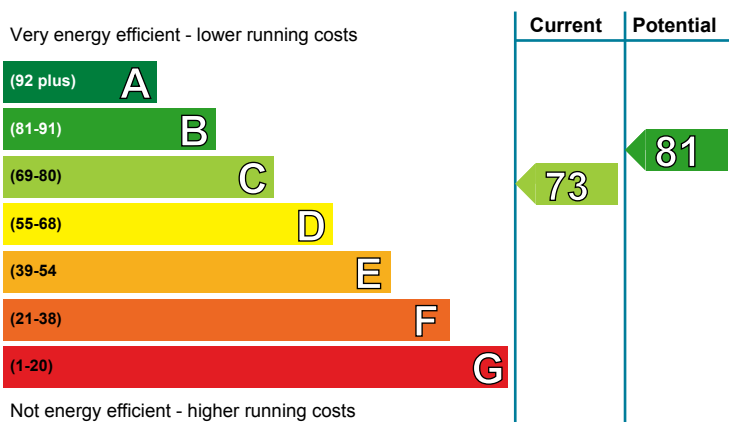
Energy Efficiency Rating

This graph shows the current efficiency of your home, taking into account both energy efficiency and fuel costs. The higher this rating, the lower your fuel bills are likely to be.

Your current rating is **band C (73)**. The average rating for EPCs in Scotland is **band D (61)**.

The potential rating shows the effect of undertaking all of the improvement measures listed within your recommendations report.
