# Home Report

# Scottish Single Survey

<b>Property address</b>	124 Inveresk Road Musselburgh EH21 7AY
<b>Customer</b>	Guardianship of Euphemia Joan Smith
<b>Customer address</b>	124 Inveresk Road Musselburgh EH21 7AY
<b>Prepared by</b>	Shepherd Chartered Surveyors
<b>Date of inspection</b>	13/11/2023

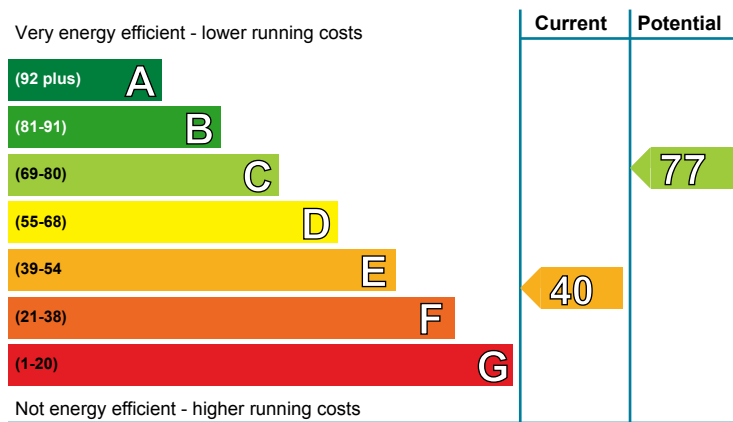
## Energy Efficiency Rating

This graph shows the current efficiency of your home, taking into account both energy efficiency and fuel costs. The higher this rating, the lower your fuel bills are likely to be.

Your current rating is **band E (40)**. The average rating for EPCs in Scotland is **band D (61)**.

The potential rating shows the effect of undertaking all of the improvement measures listed within your recommendations report.

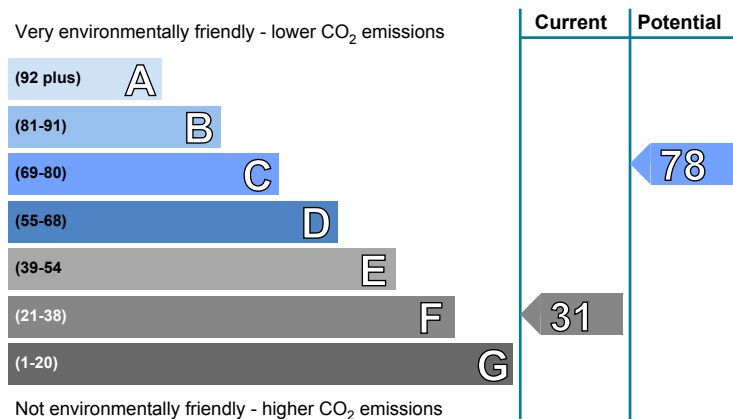
## Environmental Impact (CO<sub>2</sub>) Rating

This graph shows the effect of your home on the environment in terms of carbon dioxide (CO<sub>2</sub>) emissions. The higher the rating, the less impact it has on the environment.
