130 MAYFIELD ROAD
MAYFIELD
EDINBURGH
EH9 3AH

Home Report

Energy Performance Certificate

Scottish Single Survey

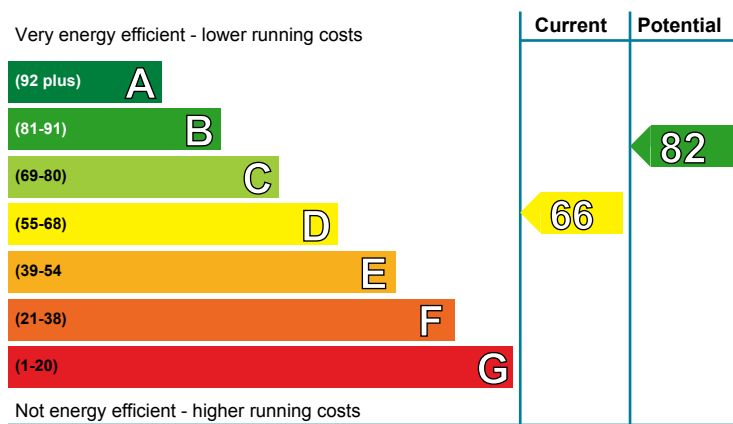
Energy Efficiency Rating

This graph shows the current efficiency of your home, taking into account both energy efficiency and fuel costs. The higher this rating, the lower your fuel bills are likely to be.

Your current rating is **band D (66)**. The average rating for EPCs in Scotland is **band D (61)**.

The potential rating shows the effect of undertaking all of the improvement measures listed within your recommendations report.

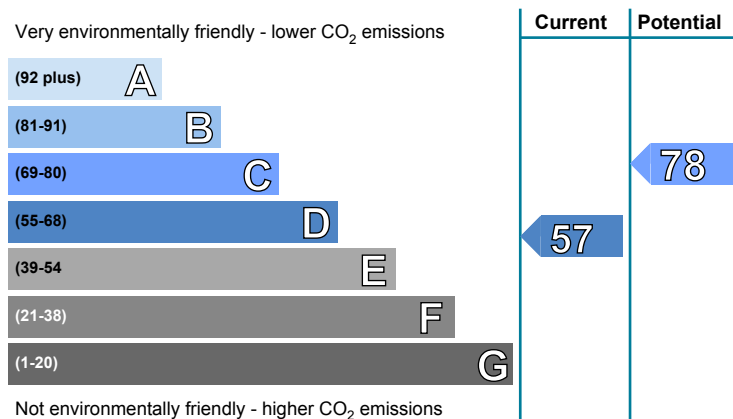
Environmental Impact (CO₂) Rating

This graph shows the effect of your home on the environment in terms of carbon dioxide (CO₂) emissions. The higher the rating, the less impact it has on the environment.

Your current rating is **band D (57)**. The average rating for EPCs in Scotland is **band D (59)**.

The potential rating shows the effect of undertaking all of the improvement measures listed within your recommendations report.
