FLAT 2
9 NEW CUT RIGG
TRINITY
EDINBURGH
EH6 4QR

Home Report

FLAT 2 , 9 NEW CUT RIGG, TRINITY, EDINBURGH, EH6 4QR

Dwelling type: Ground-floor flat
Date of assessment: 02 April 2024
Date of certificate: 04 April 2024
Total floor area: 85 m²
Primary Energy Indicator: 179 kWh/m²/year

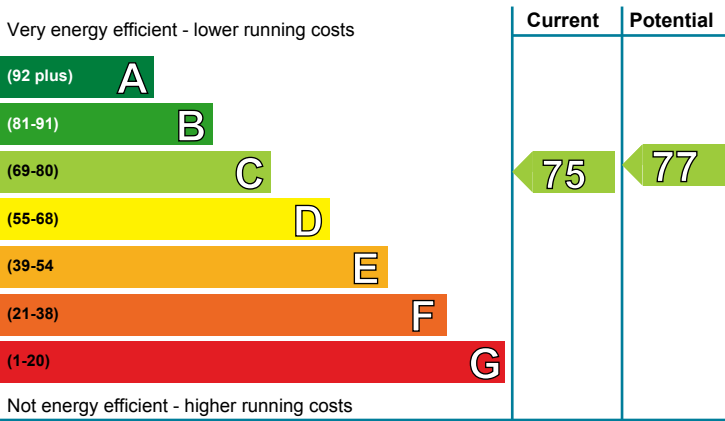
Energy Efficiency Rating

This graph shows the current efficiency of your home, taking into account both energy efficiency and fuel costs. The higher this rating, the lower your fuel bills are likely to be.

Your current rating is **band C (75)**. The average rating for EPCs in Scotland is **band D (61)**.

The potential rating shows the effect of undertaking all of the improvement measures listed within your recommendations report.

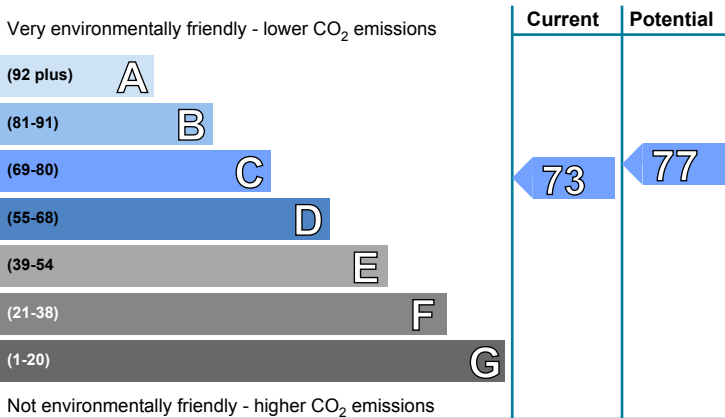
Environmental Impact (CO₂) Rating

This graph shows the effect of your home on the environment in terms of carbon dioxide (CO₂) emissions. The higher the rating, the less impact it has on the environment.

Your current rating is **band C (73)**. The average rating for EPCs in Scotland is **band D (59)**.

The potential rating shows the effect of undertaking all of the improvement measures listed within your recommendations report.
