survey report on:

Property address	19 Munnoch Way
	Plean
	FK7 8GA
Customer	Iniki Investments
Customer	By Email Only
address	
Prepared by	Graham + Sibbald, Chartered Surveyors

Description	The subjects comprise a two storey Detached Villa.

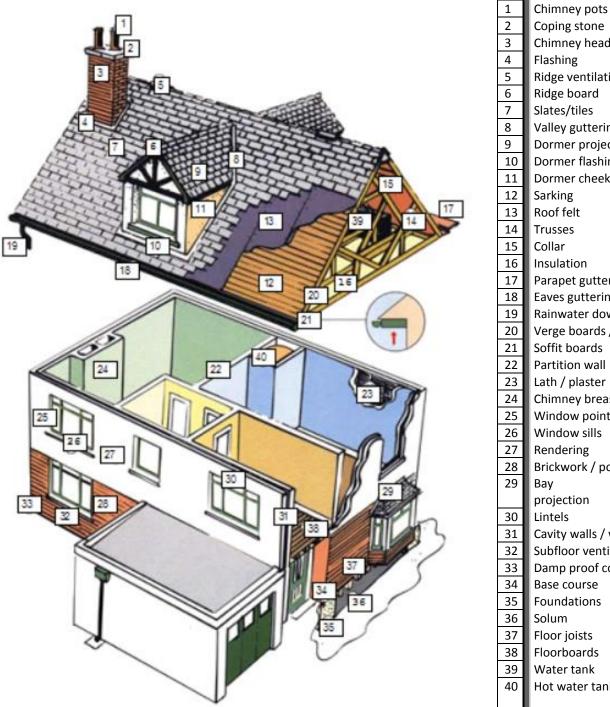
Sectional Diagram showing elements of a typical house

Coping stone Chimney head Flashing **Ridge ventilation** Ridge board Slates/tiles Valley guttering Dormer projection Dormer flashing Dormer cheeks Sarking Roof felt Trusses Collar Insulation Parapet gutter Eaves guttering Rainwater downpipe Verge boards / skews Soffit boards Partition wall Lath / plaster Chimney breast Window pointing Window sills Rendering Brickwork / pointing Bay window projection Lintels Cavity walls / wall ties Subfloor ventilator Damp proof course Base course Foundations Solum Floor joists Floorboards Water tank Hot water tank

Reference may be made in this report to some or all of the above component parts of the property. This diagram may assist you in locating and understanding these items.
