single survey

survey report on:

Property address	
•	19 Kent Road
	Braehead
	Stirling
	FK7 7PP

Prepared by	Graham + Sibbald, Chartered Surveyors
-------------	---------------------------------------

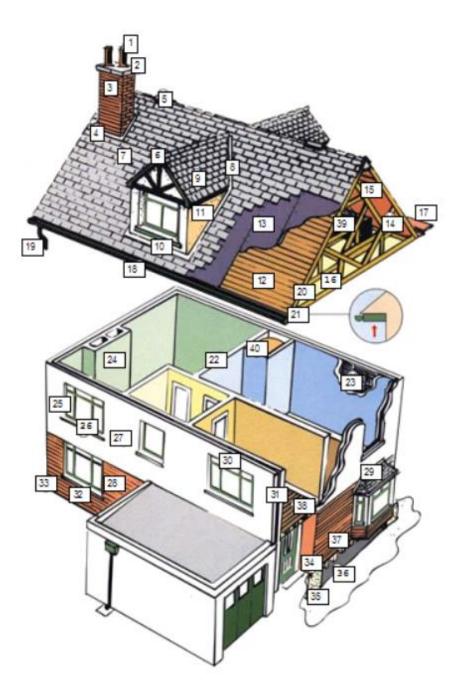
Sectional Diagram showing elements of a typical house

Reference may be made in this report to some or all of the above component parts of the property. This diagram may assist you in locating and

Chimney pots 2 Coping stone 3 Chimney head 4 **Flashing** 5 Ridge ventilation 6 Ridge board 7 Slates/tiles Valley guttering Dormer projection 10 Dormer flashing 11 Dormer cheeks 12 Sarking 13 Roof felt 14 Trusses 15 Collar 16 Insulation 17 Parapet gutter 18 Eaves guttering 19 Rainwater downpipe 20 Verge boards / skews 21 Soffit boards 22 Partition wall 23 Lath / plaster 24 Chimney breast 25 Window pointing Window sills 27 Rendering 28 Brickwork / pointing 29 Bay window projection 30 Lintels 31 Cavity walls / wall ties 32 Subfloor ventilator
