Home Report

Single Survey

Property address	Woodend Farm Glenboig Coatbridge ML5 2QH
-------------------------	---

Prepared by	Shepherd Chartered Surveyors
--------------------	------------------------------

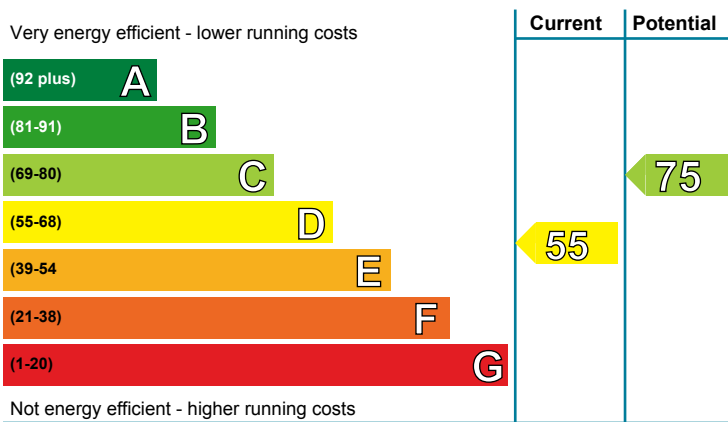
Energy Efficiency Rating

This graph shows the current efficiency of your home, taking into account both energy efficiency and fuel costs. The higher this rating, the lower your fuel bills are likely to be.

Your current rating is **band D (55)**. The average rating for EPCs in Scotland is **band D (61)**.

The potential rating shows the effect of undertaking all of the improvement measures listed within your recommendations report.
