espc:home report

47/8 Stenhouse Gardens, Stenhouse
EDINBURGH
EH11 3LS
27/02/2024

Single Survey

Property address	Flat 8, 47 Stenhouse Gardens, Stenhouse, EDINBURGH, EH11 3LS
-------------------------	--

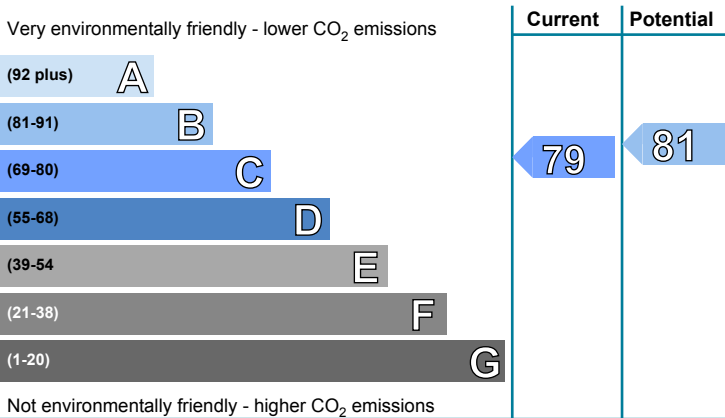
Environmental Impact (CO₂) Rating

This graph shows the effect of your home on the environment in terms of carbon dioxide (CO₂) emissions. The higher the rating, the less impact it has on the environment.
