espc:home report

85/6 East London Street, New Town
EDINBURGH
EH7 4BQ
26/03/2024

Single Survey

Property address	Flat 6, 85 East London Street, Broughton, EDINBURGH, EH7 4BQ
-------------------------	--

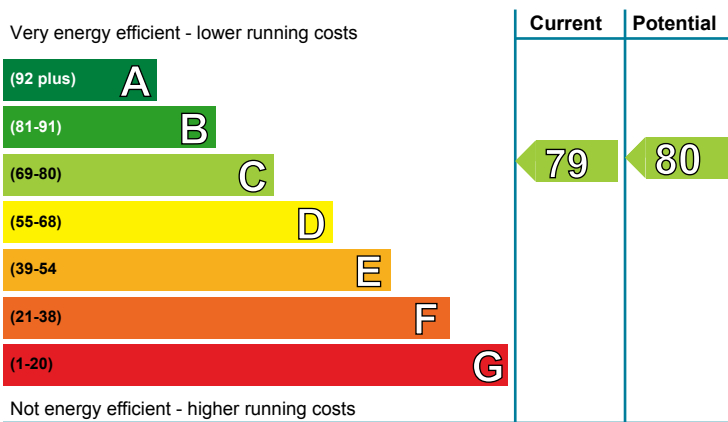
Energy Efficiency Rating

This graph shows the current efficiency of your home, taking into account both energy efficiency and fuel costs. The higher this rating, the lower your fuel bills are likely to be.

Your current rating is **band C (79)**. The average rating for EPCs in Scotland is **band D (61)**.

The potential rating shows the effect of undertaking all of the improvement measures listed within your recommendations report.
