espc:home report

80 (PF) Duke Street
Leith, Edinburgh
EH6 8HL
18/04/2024

Single Survey

survey report on:

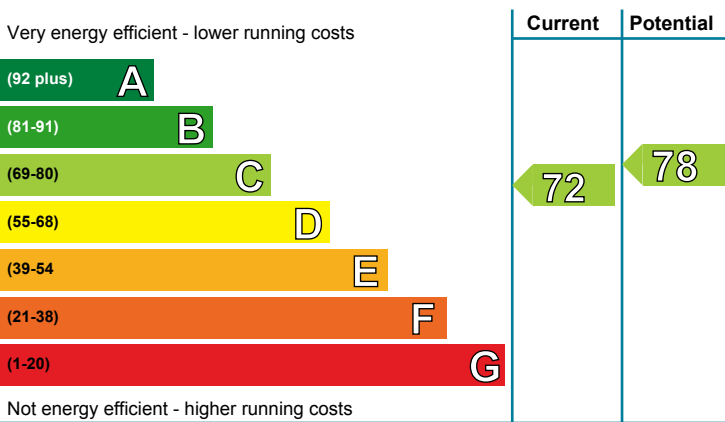
Energy Efficiency Rating

This graph shows the current efficiency of your home, taking into account both energy efficiency and fuel costs. The higher this rating, the lower your fuel bills are likely to be.

Your current rating is **band C (72)**. The average rating for EPCs in Scotland is **band D (61)**.

The potential rating shows the effect of undertaking all of the improvement measures listed within your recommendations report.

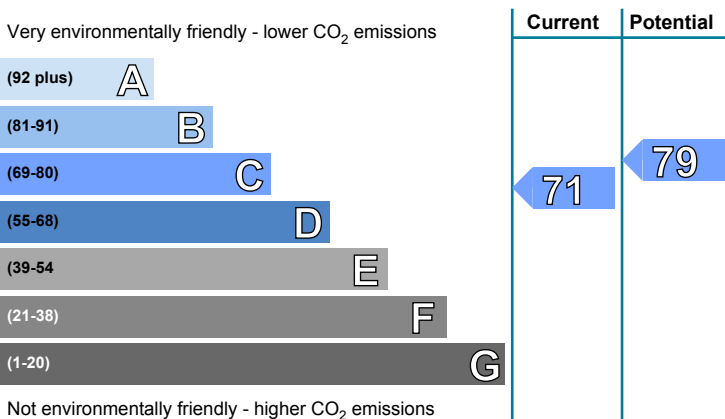
Environmental Impact (CO₂) Rating

This graph shows the effect of your home on the environment in terms of carbon dioxide (CO₂) emissions. The higher the rating, the less impact it has on the environment.
