HOME REPORT

FLAT
1 ETTRICK BANK
DUCHAL ROAD
KILMACOLM
PA13 4AS

Energy Performance Certificate (EPC)

Single Survey

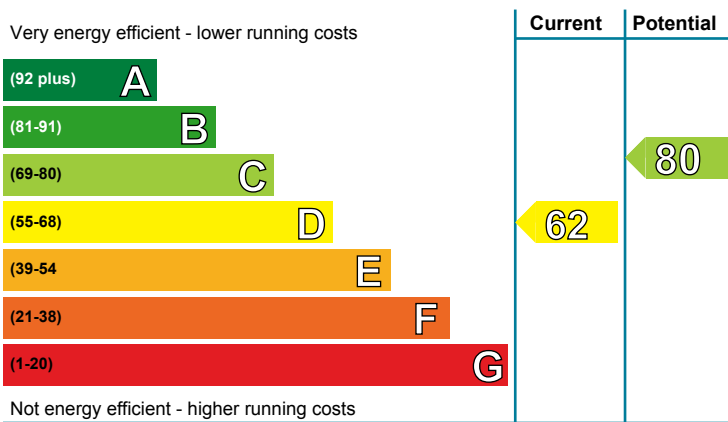
Energy Efficiency Rating

This graph shows the current efficiency of your home, taking into account both energy efficiency and fuel costs. The higher this rating, the lower your fuel bills are likely to be.

Your current rating is **band D (62)**. The average rating for EPCs in Scotland is **band D (61)**.

The potential rating shows the effect of undertaking all of the improvement measures listed within your recommendations report.

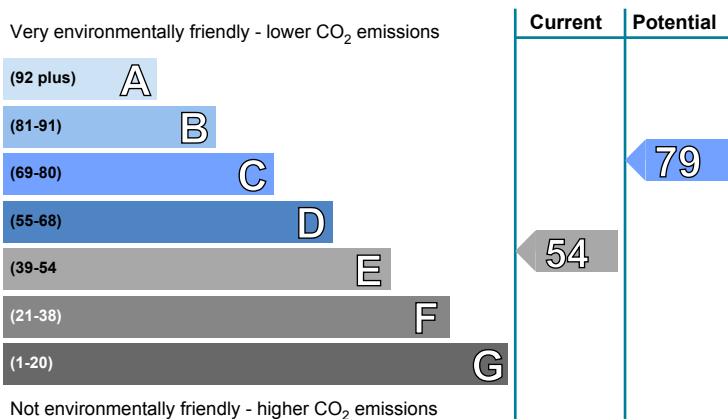
Environmental Impact (CO₂) Rating

This graph shows the effect of your home on the environment in terms of carbon dioxide (CO₂) emissions. The higher the rating, the less impact it has on the environment.

Your current rating is **band E (54)**. The average rating for EPCs in Scotland is **band D (59)**.

The potential rating shows the effect of undertaking all of the improvement measures listed within your recommendations report.
