Home Report

Flat 1/3 26 John Neilson Avenue Paisley PA1 2SR

single survey

Property address	Flat 1/3
. ,	26 John Neilson Avenue
	Paisley
	PA1 2SR

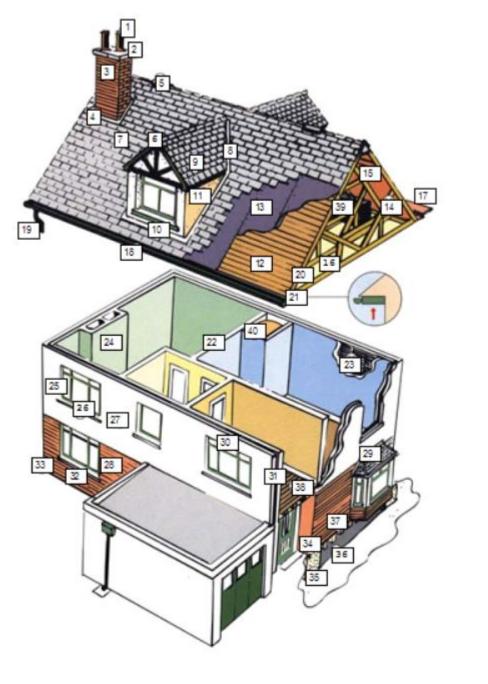
Sectional Diagram showing elements of a typical house

Reference may be made in this report to some or all of the above component parts of the property. This diagram may assist you in locating and understanding these items.

1	Chimney pots
2	Coping stone
3	Chimney head
4 5	Flashing
	Ridge ventilation
6	Ridge board
7	Slates/tiles
8	Valley guttering
9	Dormer projection
10	Dormer flashing
11	Dormer cheeks
12	Sarking
13	Roof felt
14	Trusses
15	Collar
16	Insulation
17	Parapet gutter
18	Eaves guttering
19	Rainwater downpipe
20	Verge boards / skews
21	Soffit boards
22	Partition wall
23	Lath / plaster
24	Chimney breast
25	Window pointing
26	Window sills
27	Rendering
28	Brickwork / pointing
29	Bay window
30	Lintels
31	Cavity walls / wall ties
32	Subfloor ventilator
33	Damp proof course
34	Base course
35	Foundations
36	Solum
37	Floor joists
38	Floorboards
39	Water tank
40	Hot water tank
