Home Report

Scottish Single Survey

Property address	26 Arniston Way Paisley PA3 4BZ
Customer	Anna Castelvevchi
Customer address	26 Arniston Way Paisley PA3 4BZ
Prepared by	Shepherd Chartered Surveyors
Date of inspection	25/04/2024

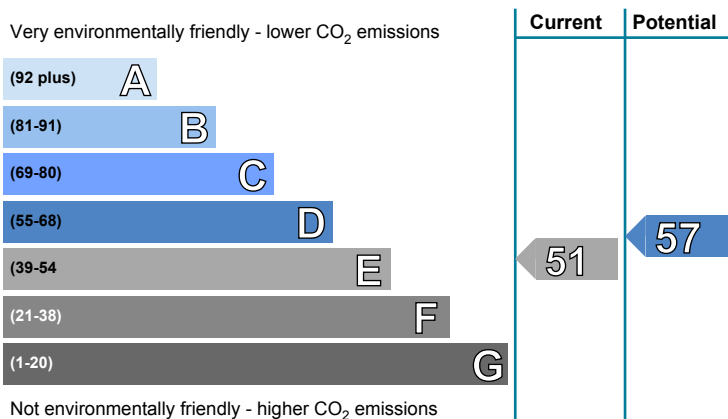
Environmental Impact (CO₂) Rating

This graph shows the effect of your home on the environment in terms of carbon dioxide (CO₂) emissions. The higher the rating, the less impact it has on the environment.
