espc:home report

28 Gogarloch Bank, South Gyle
Edinburgh
EH12 9LA
03/05/2024

Single Survey

Property address	28 Gogarloch Bank, South Gyle, Edinburgh, EH12 9LA
-------------------------	---

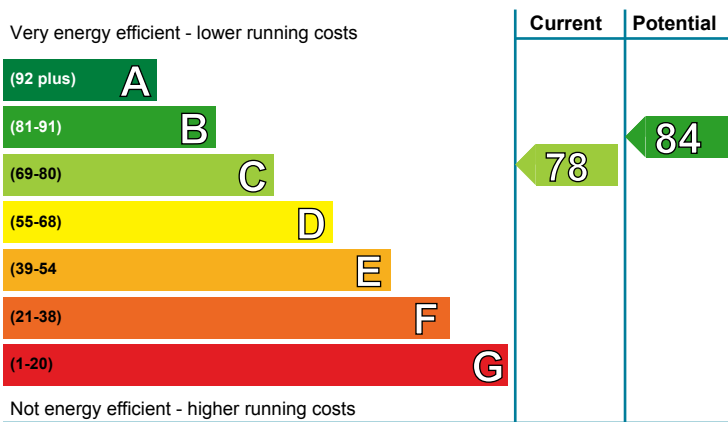
Energy Efficiency Rating

This graph shows the current efficiency of your home, taking into account both energy efficiency and fuel costs. The higher this rating, the lower your fuel bills are likely to be.

Your current rating is **band C (78)**. The average rating for EPCs in Scotland is **band D (61)**.

The potential rating shows the effect of undertaking all of the improvement measures listed within your recommendations report.
