espc:home report

11 Broomhill Drive
Eskbank
EH22 3JU
26/04/2024

Single Survey

Property address	11 Broomhill Drive, Eskbank, Dalkeith, EH22 3JU
-------------------------	--

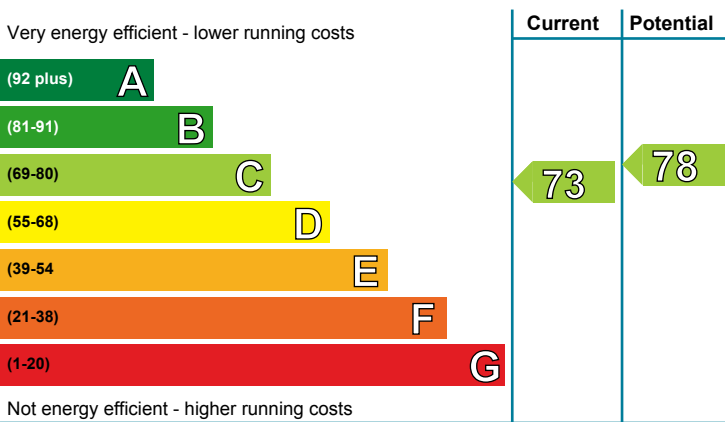
Energy Efficiency Rating

This graph shows the current efficiency of your home, taking into account both energy efficiency and fuel costs. The higher this rating, the lower your fuel bills are likely to be.

Your current rating is **band C (73)**. The average rating for EPCs in Scotland is **band D (61)**.

The potential rating shows the effect of undertaking all of the improvement measures listed within your recommendations report.

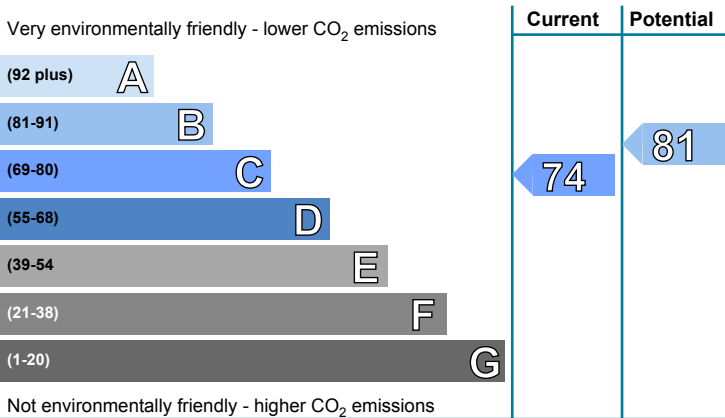
Environmental Impact (CO₂) Rating

This graph shows the effect of your home on the environment in terms of carbon dioxide (CO₂) emissions. The higher the rating, the less impact it has on the environment.
