espc:home report

71/6 Gracemount Avenue, Gracemount
Edinburgh
EH16 6SR
01/05/2024

Home Report Index

Property address	2F2, 71 Gracemount Avenue, Gracemount, Edinburgh, EH16 6SR
-------------------------	--

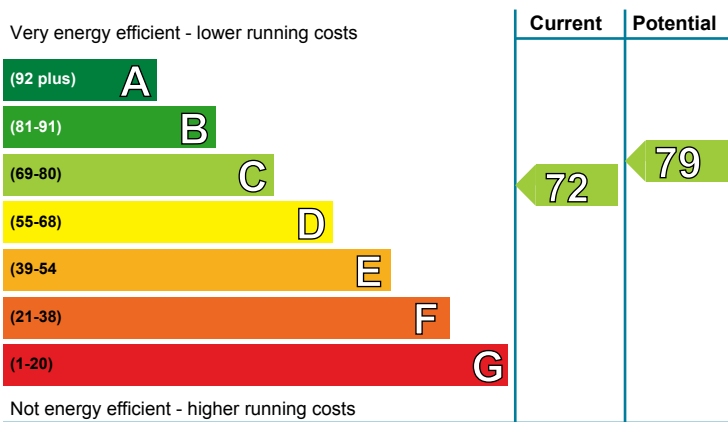
Energy Efficiency Rating

This graph shows the current efficiency of your home, taking into account both energy efficiency and fuel costs. The higher this rating, the lower your fuel bills are likely to be.

Your current rating is **band C (72)**. The average rating for EPCs in Scotland is **band D (61)**.

The potential rating shows the effect of undertaking all of the improvement measures listed within your recommendations report.
