## Home Report

35 Renshaw Road Bishopton PA7 5HN

# single survey

## survey report on:

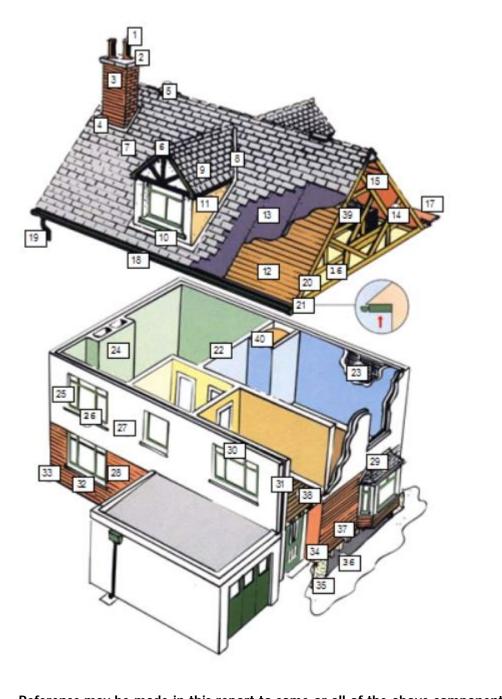
## Sectional Diagram showing elements of a typical house

Chimney pots 1 Coping stone 2 3 Chimney head Flashing 4 Ridge ventilation 5 Ridge board 6 7 Slates/tiles 8 Valley guttering 9 Dormer projection Dormer flashing 10 Dormer cheeks 11 12 Sarking Roof felt 13 Trusses 14 15 Collar 16 Insulation 17 Parapet gutter Eaves guttering 18 Rainwater downpipe 19 20 Verge boards / skews 21 Soffit boards 22 Partition wall Lath / plaster 23 24 Chimney breast 25 Window pointing Window sills 26 Rendering 27 Brickwork / pointing 28 Bay window 29 30 Lintels 31 Cavity walls / wall ties Subfloor ventilator 32 33 Damp proof course 34 Base course 35 Foundations Solum 36 37 Floor joists Floorboards 38 Water tank 39 40 Hot water tank

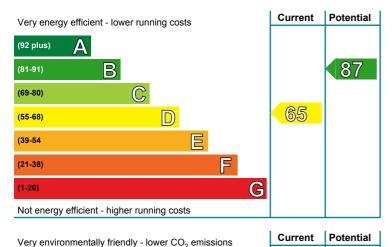
## **Energy Efficiency Rating**

This graph shows the current efficiency of your home, taking into account both energy efficiency and fuel costs. The higher this rating, the lower your fuel bills are likely to be.
