Home Report

95 Gartmore Road
Paisley
PA1 3JS

single survey

Property address	95 Gartmore Road Paisley PA1 3JS
Customer	Client of Cochran Dickie
Prepared by	Graham + Sibbald LLP

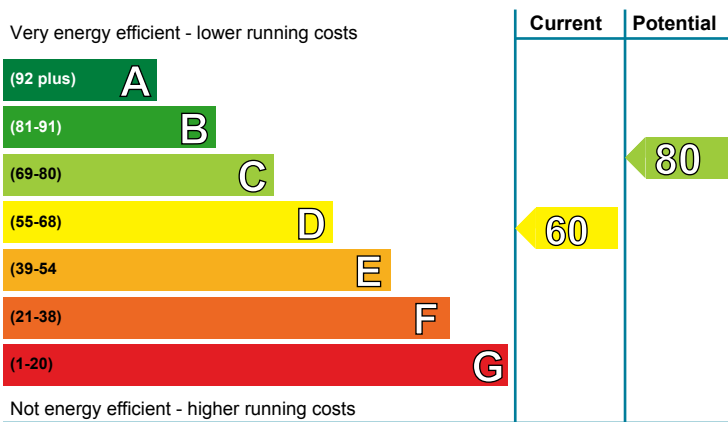
Energy Efficiency Rating

This graph shows the current efficiency of your home, taking into account both energy efficiency and fuel costs. The higher this rating, the lower your fuel bills are likely to be.

Your current rating is **band D (60)**. The average rating for EPCs in Scotland is **band D (61)**.

The potential rating shows the effect of undertaking all of the improvement measures listed within your recommendations report.

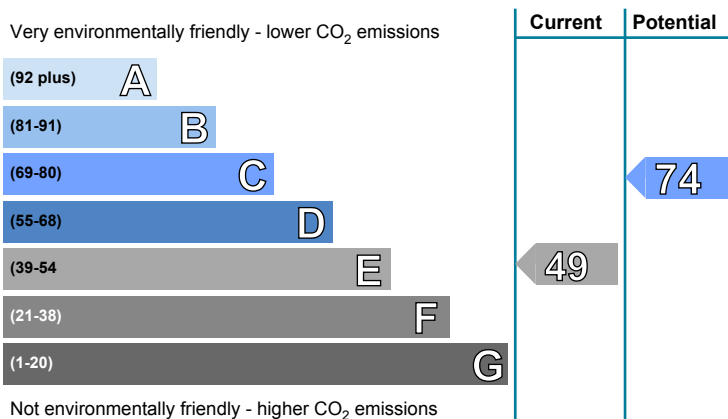
Environmental Impact (CO₂) Rating

This graph shows the effect of your home on the environment in terms of carbon dioxide (CO₂) emissions. The higher the rating, the less impact it has on the environment.
