# Home Report

# Scottish Single Survey

<b>Property address</b>	13/6 Whitehaugh Drive Paisley PA1 3PG
-------------------------	---------------------------------------------

<b>Prepared by</b>	Shepherd Chartered Surveyors
--------------------	------------------------------

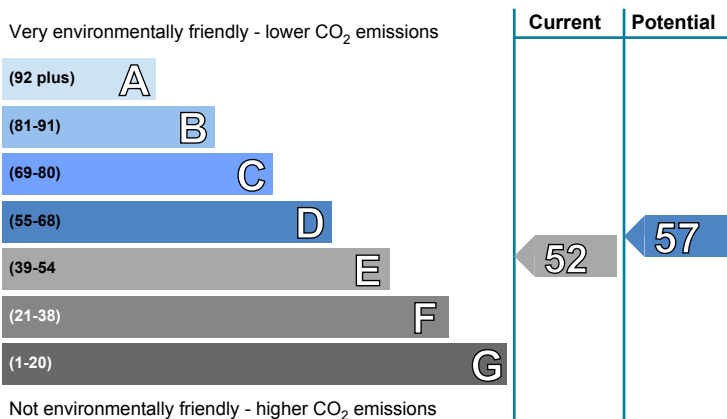
## Environmental Impact (CO<sub>2</sub>) Rating

This graph shows the effect of your home on the environment in terms of carbon dioxide (CO<sub>2</sub>) emissions. The higher the rating, the less impact it has on the environment.
