Home Report

Scottish Single Survey

Property address	15 High Calside Paisley PA2 6BY
-------------------------	---------------------------------------

Prepared by	Shepherd Chartered Surveyors
--------------------	------------------------------

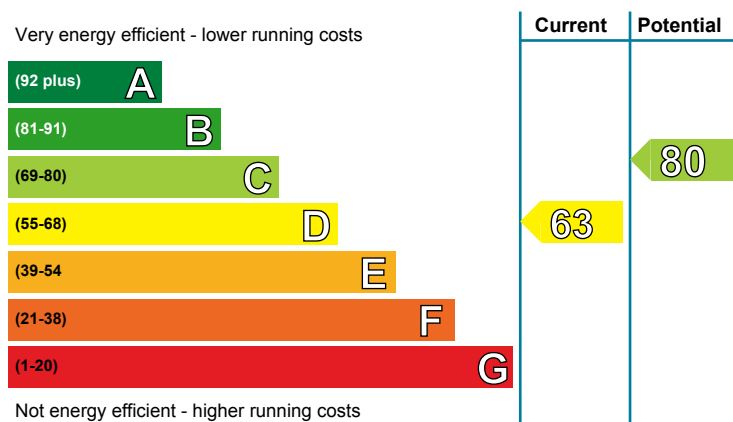
Energy Efficiency Rating

This graph shows the current efficiency of your home, taking into account both energy efficiency and fuel costs. The higher this rating, the lower your fuel bills are likely to be.

Your current rating is **band D (63)**. The average rating for EPCs in Scotland is **band D (61)**.

The potential rating shows the effect of undertaking all of the improvement measures listed within your recommendations report.

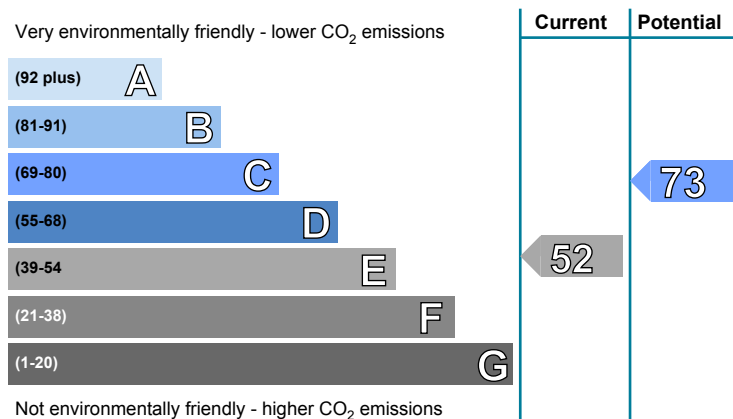
Environmental Impact (CO₂) Rating

This graph shows the effect of your home on the environment in terms of carbon dioxide (CO₂) emissions. The higher the rating, the less impact it has on the environment.
