# Home Report Index

## **SINGLE SURVEY REPORT**

**22 GREENFIELD CRESCENT  
BALERNO  
EH14 7HD**

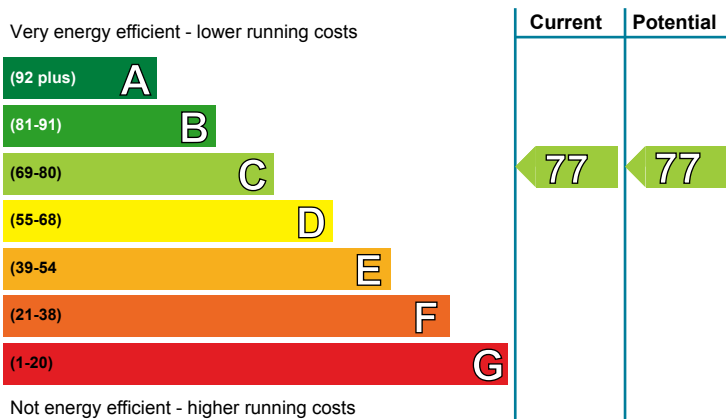
## Energy Efficiency Rating

This graph shows the current efficiency of your home, taking into account both energy efficiency and fuel costs. The higher this rating, the lower your fuel bills are likely to be.

Your current rating is **band C (77)**. The average rating for EPCs in Scotland is **band D (61)**.

The potential rating shows the effect of undertaking all of the improvement measures listed within your recommendations report.

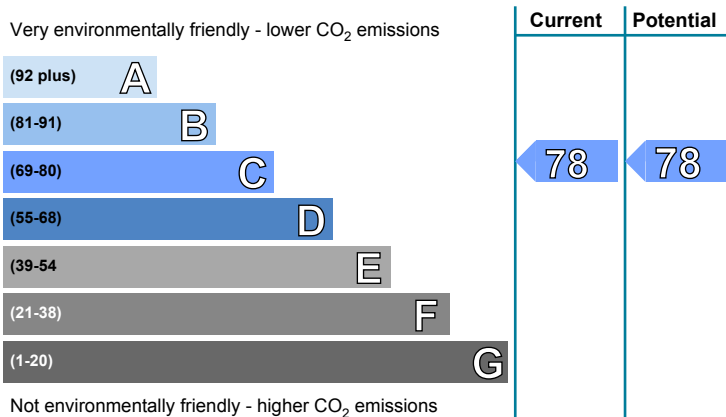
## Environmental Impact (CO<sub>2</sub>) Rating

This graph shows the effect of your home on the environment in terms of carbon dioxide (CO<sub>2</sub>) emissions. The higher the rating, the less impact it has on the environment.
