# Home Report Index

# Single Survey

<b>Property address</b>	61 Comely Bank Avenue, Stockbridge, Edinburgh, EH4 1ET
-------------------------	---

<b>Prepared by</b>	ALLIED SURVEYORS SCOTLAND PLC
--------------------	-------------------------------

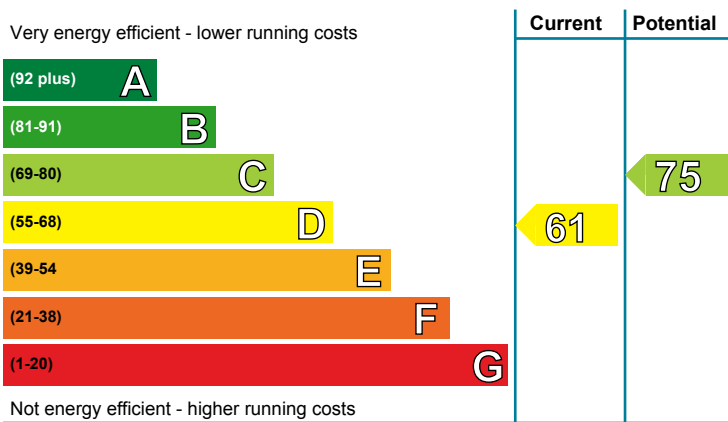
## Energy Efficiency Rating

This graph shows the current efficiency of your home, taking into account both energy efficiency and fuel costs. The higher this rating, the lower your fuel bills are likely to be.
