57 Morningside Drive
Edinburgh
EH10 5NF
28/03/2024

Single Survey

| Property address | 57 Morningside Drive, Morningside, Edinburgh, EH10 5NF |

| Prepared by | Graham & Sibbald |

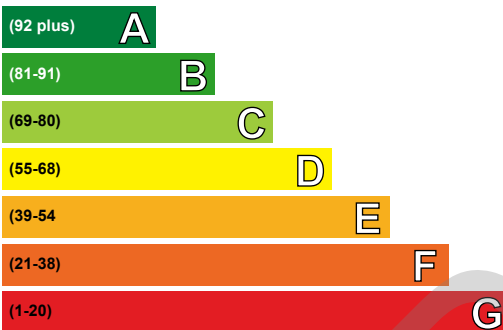
* based upon the cost of energy for heating, hot water, lighting and ventilation, calculated using standard assumptions

Very energy efficient - lower running costs

Not energy efficient - higher running costs

The potential rating shows the effect of undertaking all of the improvement measures listed within your recommendations report.

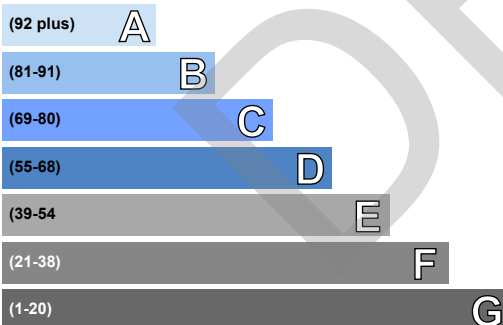
Very environmentally friendly - lower CO₂ emissions

Not environmentally friendly - higher CO₂ emissions
