# Home Report Index

# Single Survey

Property address	7 Winchburgh Road, Winchburgh, Broxburn, EH52 6QB
------------------	--

Prepared by	J & E Shepherd
-------------	----------------

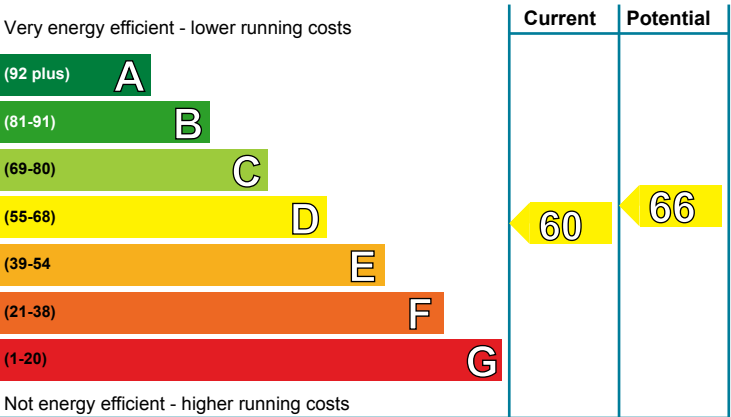
### Energy Efficiency Rating

This graph shows the current efficiency of your home, taking into account both energy efficiency and fuel costs. The higher this rating, the lower your fuel bills are likely to be.

Your current rating is **band D (60)**. The average rating for EPCs in Scotland is **band D (61)**.

The potential rating shows the effect of undertaking all of the improvement measures listed within your recommendations report.

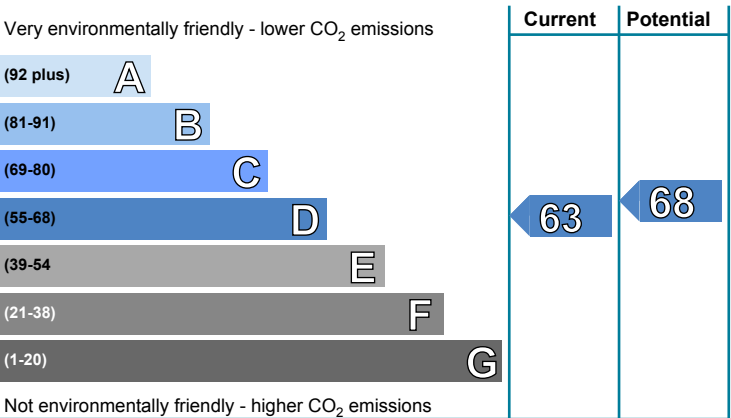
### Environmental Impact (CO<sub>2</sub>) Rating

This graph shows the effect of your home on the environment in terms of carbon dioxide (CO<sub>2</sub>) emissions. The higher the rating, the less impact it has on the environment.
