1F4
110 GORGIE ROAD
GORGIE
EDINBURGH
EH11 2NP

Home Report

Energy Performance Certificate (EPC)

Scottish Single Survey

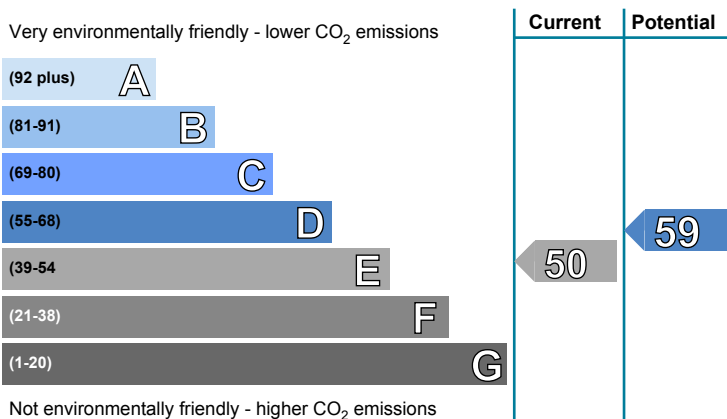
Environmental Impact (CO₂) Rating

This graph shows the effect of your home on the environment in terms of carbon dioxide (CO₂) emissions. The higher the rating, the less impact it has on the environment.

Your current rating is **band E (50)**. The average rating for EPCs in Scotland is **band D (59)**.

The potential rating shows the effect of undertaking all of the improvement measures listed within your recommendations report.
