single survey

survey report on:

Property address	32 C Queen Street Stirling FK8 1HN
Customer	Clare Wallace
Customer address	
Prepared by	Graham + Sibbald, Chartered Surveyors

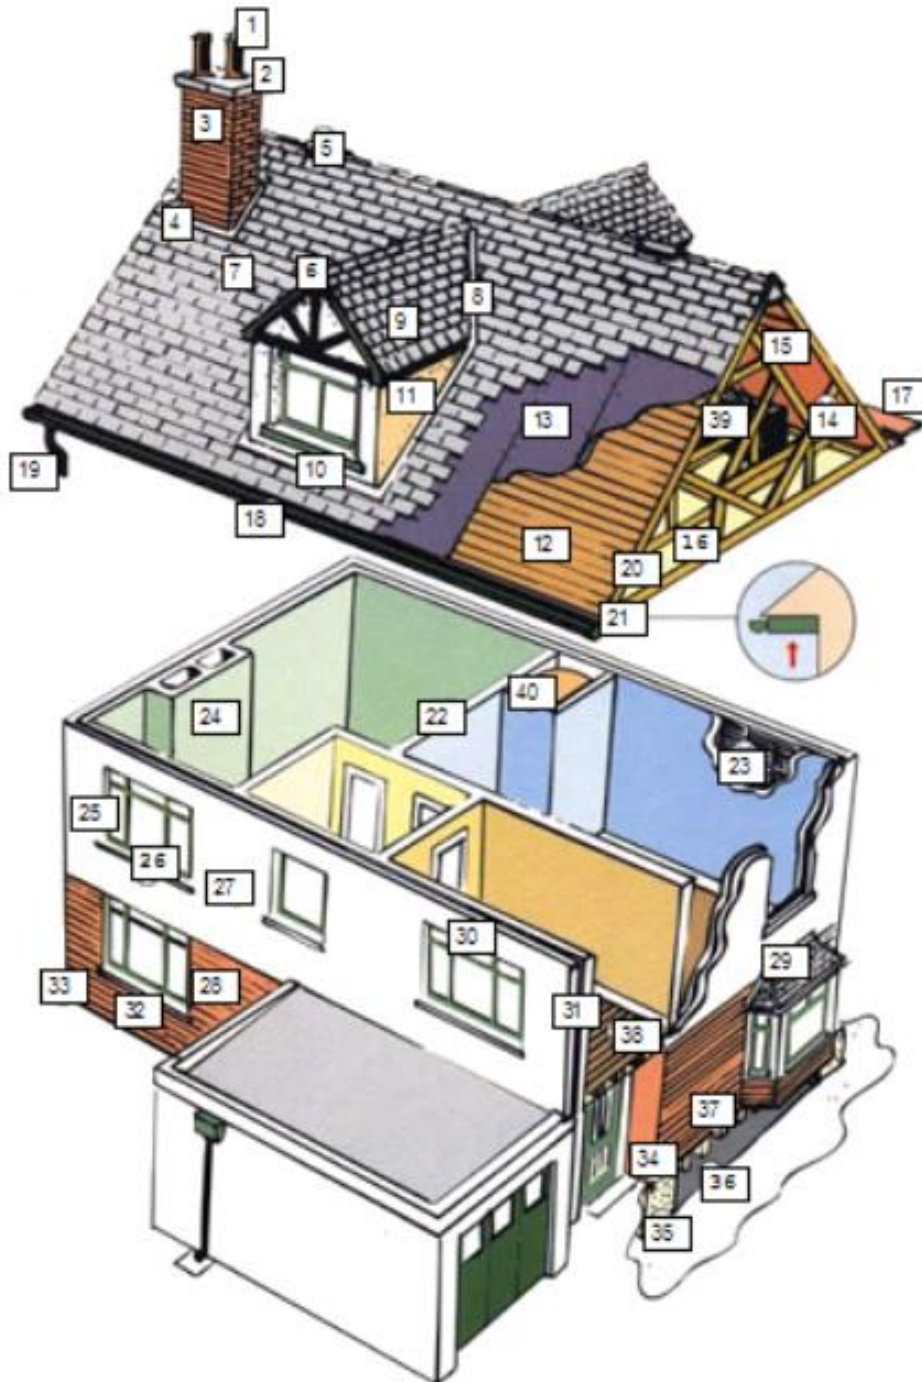
Sectional Diagram showing elements of a typical house

1	Chimney pots
2	Coping stone
3	Chimney head
4	Flashing
5	Ridge ventilation
6	Ridge board
7	Slates/tiles
8	Valley guttering
9	Dormer projection
10	Dormer flashing
11	Dormer cheeks
12	Sarking
13	Roof felt
14	Trusses
15	Collar
16	Insulation
17	Parapet gutter
18	Eaves guttering
19	Rainwater downpipe
20	Verge boards / skewes
21	Soffit boards
22	Partition wall
23	Lath / plaster
24	Chimney breast
25	Window pointing
26	Window sills
27	Rendering
28	Brickwork / pointing
29	Bay window projection
30	Lintels
31	Cavity walls / wall ties
32	Subfloor ventilator
33	Damp proof course
34	Base course
35	Foundations
36	Solum
37	Floor joists
38	Floorboards
39	Water tank
40	Hot water tank

Reference may be made in this report to some or all of the above component parts of the property. This diagram may assist you in locating and understanding these items.

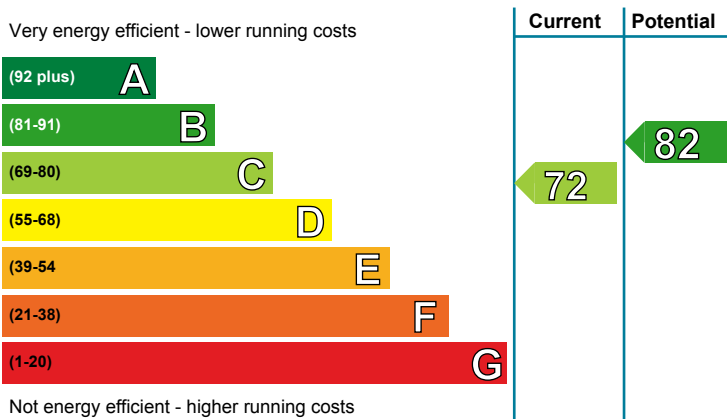
Energy Efficiency Rating

This graph shows the current efficiency of your home, taking into account both energy efficiency and fuel costs. The higher this rating, the lower your fuel bills are likely to be.

Based on calculated energy use of **207 kWh/m²/yr**, your current rating is **band C (72)**. The average rating for a home in Scotland is **band D (61)**.

The potential rating shows the effect of undertaking all of the improvement measures listed within your recommendations report.

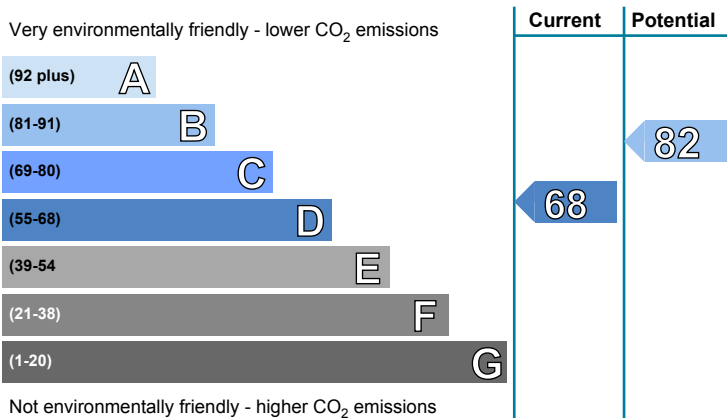
Environmental Impact (CO₂) Rating

This graph shows the effect of your home on the environment in terms of carbon dioxide (CO₂) emissions. The higher the rating, the less impact it has on the environment.
