# single survey

## survey report on:

<b>Property address</b>	Flat 2A 28 Murray Place Stirling FK8 2DD
<b>Customer</b>	Caroline McCaig
<b>Customer address</b>	4 Braehead Rumbling Bridge by Kinross KY13 0PX
<b>Prepared by</b>	Graham + Sibbald, Chartered Surveyors

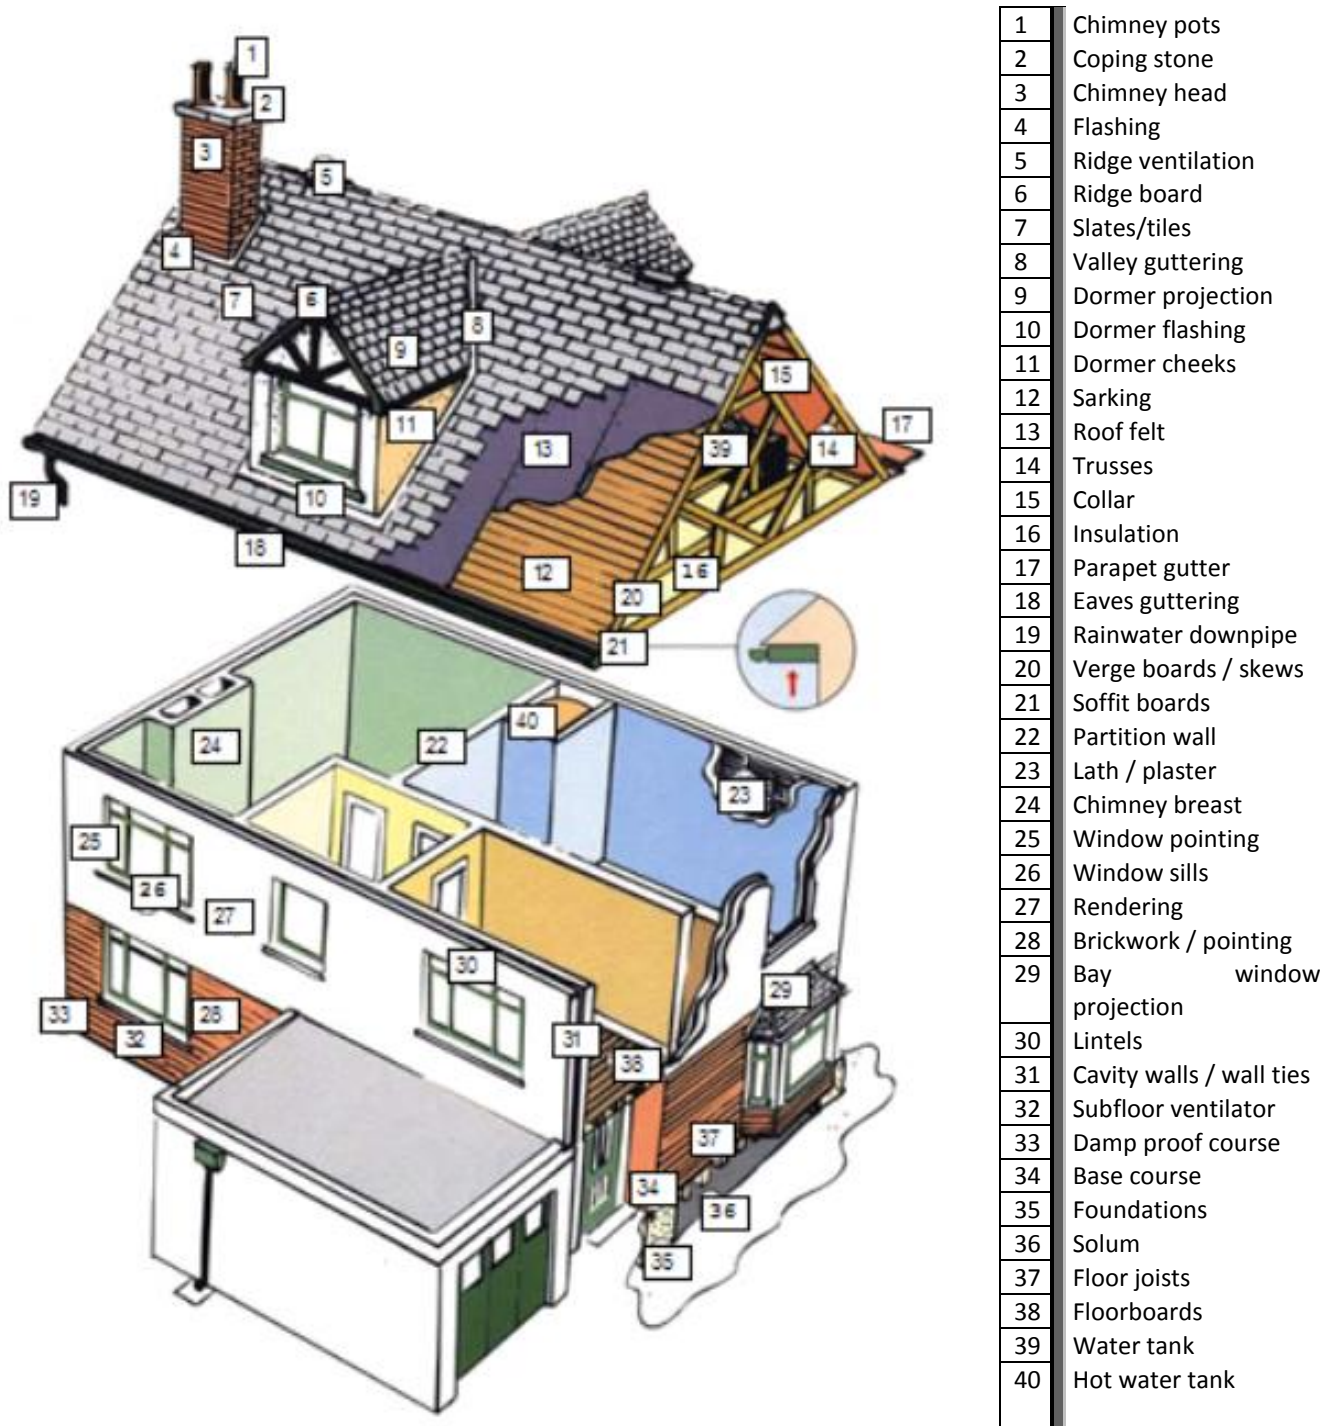
## Sectional Diagram showing elements of a typical house

Reference may be made in this report to some or all of the above component parts of the property. This diagram may assist you in locating and understanding these items.

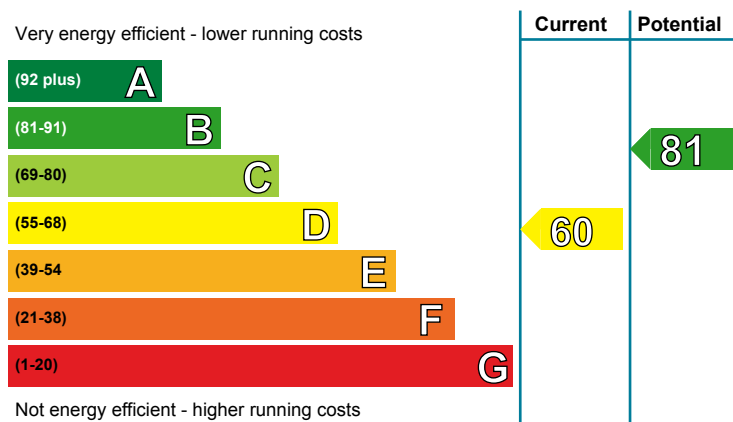
## Energy Efficiency Rating

This graph shows the current efficiency of your home, taking into account both energy efficiency and fuel costs. The higher this rating, the lower your fuel bills are likely to be.

Based on calculated energy use of **358 kWh/m<sup>2</sup>/yr**, your current rating is **band D (60)**. The average rating for a home in Scotland is **band D (61)**.

The potential rating shows the effect of undertaking all of the improvement measures listed within your recommendations report.

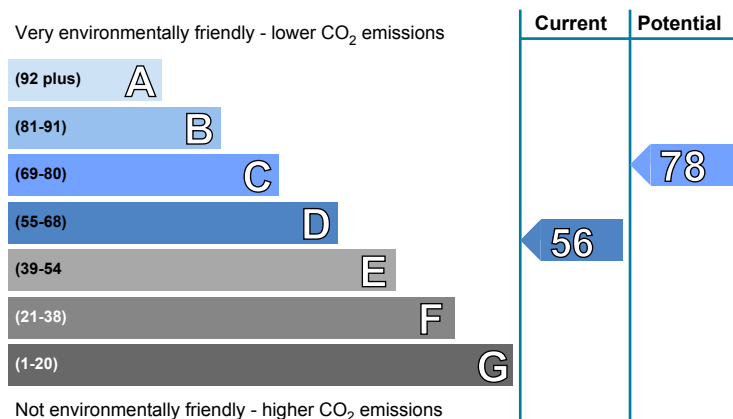
## Environmental Impact (CO<sub>2</sub>) Rating

This graph shows the effect of your home on the environment in terms of carbon dioxide (CO<sub>2</sub>) emissions. The higher the rating, the less impact it has on the environment.
