survey report on:

Property address	55 Linden Avenue Stirling FK7 7PS
Customer	Mr Alan McIntosh
Customer address	41 Lade Mill Whins of Milton Stirling FK7 0HL
Prepared by	Graham + Sibbald, Chartered Surveyors

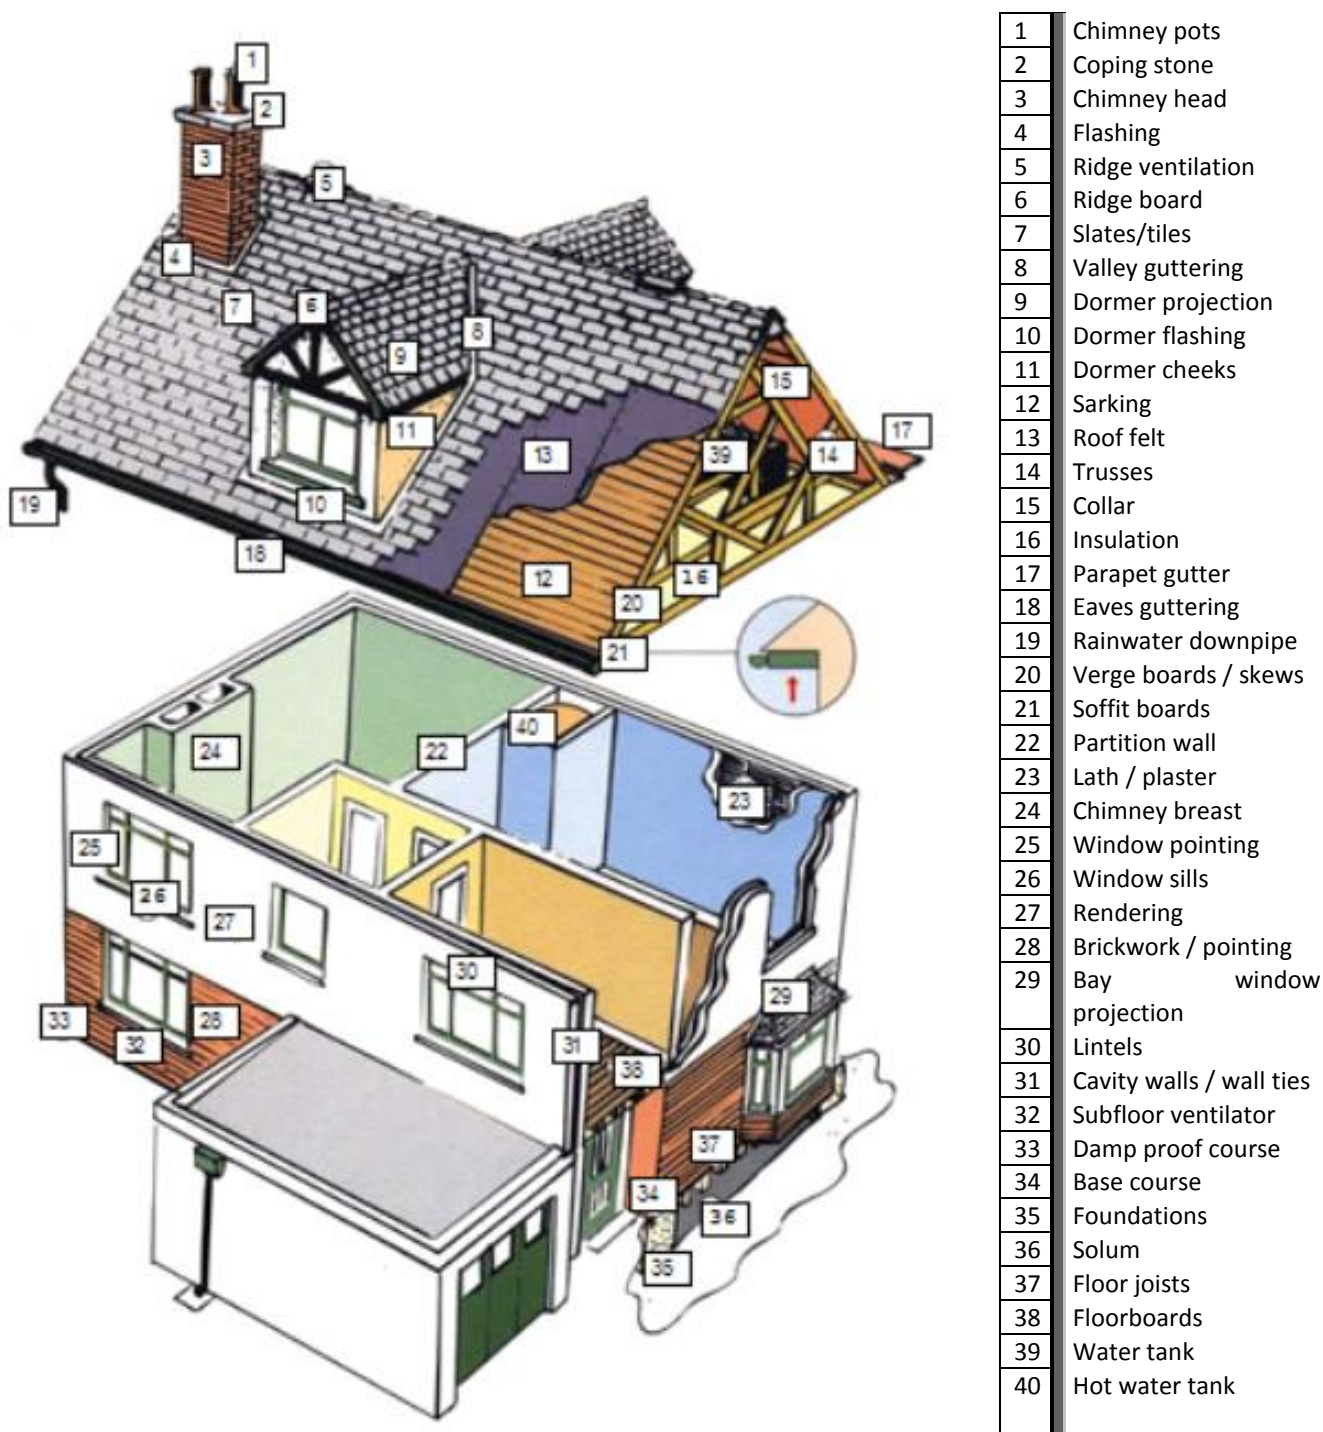
Sectional Diagram showing elements of a typical house

Reference may be made in this report to some or all of the above component parts of the property. This diagram may assist you in locating and understanding these items.

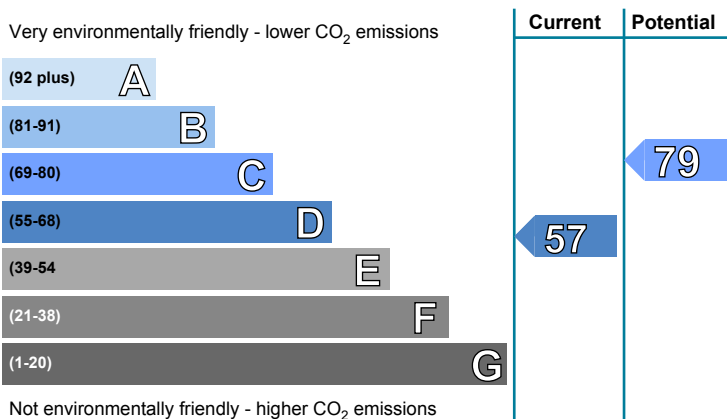
Environmental Impact (CO₂) Rating

This graph shows the effect of your home on the environment in terms of carbon dioxide (CO₂) emissions. The higher the rating, the less impact it has on the environment.
