HOME REPORT

6 BALLENGEICH ROAD
RAPLOCH
STIRLING
FK8 1TN

Energy Performance Certificate (EPC)

Single Survey

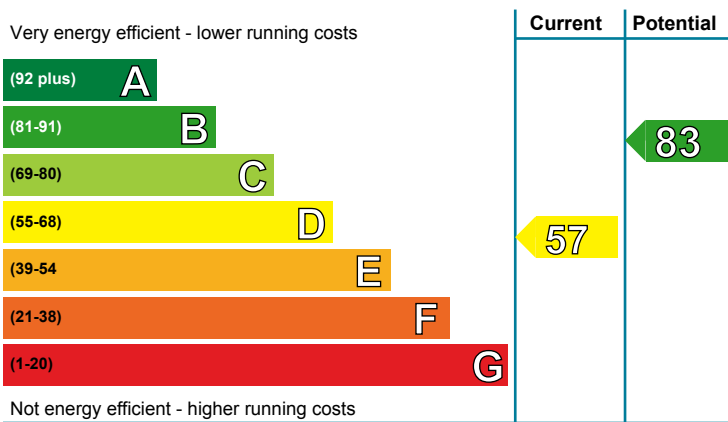
Energy Efficiency Rating

This graph shows the current efficiency of your home, taking into account both energy efficiency and fuel costs. The higher this rating, the lower your fuel bills are likely to be.

Your current rating is **band D (57)**. The average rating for EPCs in Scotland is **band D (61)**.

The potential rating shows the effect of undertaking all of the improvement measures listed within your recommendations report.

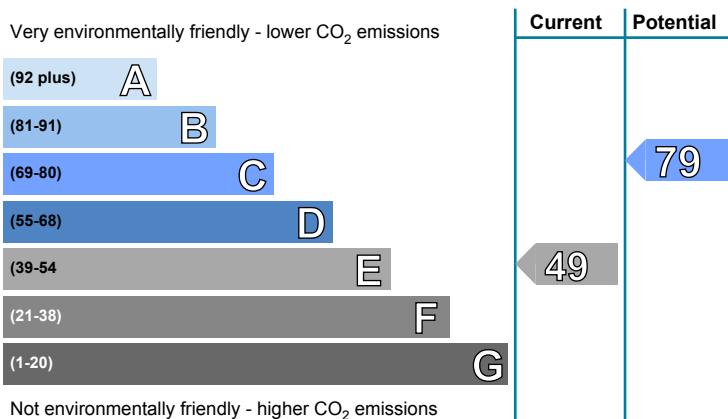
Environmental Impact (CO₂) Rating

This graph shows the effect of your home on the environment in terms of carbon dioxide (CO₂) emissions. The higher the rating, the less impact it has on the environment.

Your current rating is **band E (49)**. The average rating for EPCs in Scotland is **band D (59)**.

The potential rating shows the effect of undertaking all of the improvement measures listed within your recommendations report.
