Home Report

Scottish Single Survey

Property address	21 Dryburgh Walk Moodiesburn Glasgow G69 0HH
Customer	Mr David Coyle
Customer address	21 Dryburgh Walk Moodiesburn Glasgow G69 0HH
Prepared by	Shepherd Chartered Surveyors
Date of inspection	28/03/2024

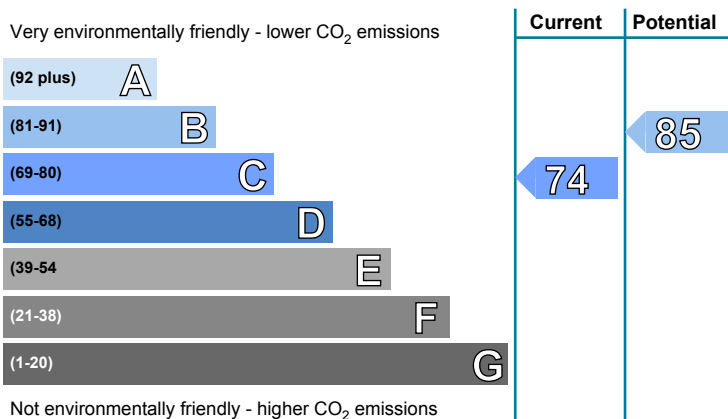
Environmental Impact (CO₂) Rating

This graph shows the effect of your home on the environment in terms of carbon dioxide (CO₂) emissions. The higher the rating, the less impact it has on the environment.
