# espc:home report

2 Balbirnie Place, Roseburn  
Edinburgh  
EH12 5JF  
12/03/2024

# Single Survey

<b>Property address</b>	2 Balbirnie Place, Roseburn, Edinburgh, EH12 5JF
-------------------------	---

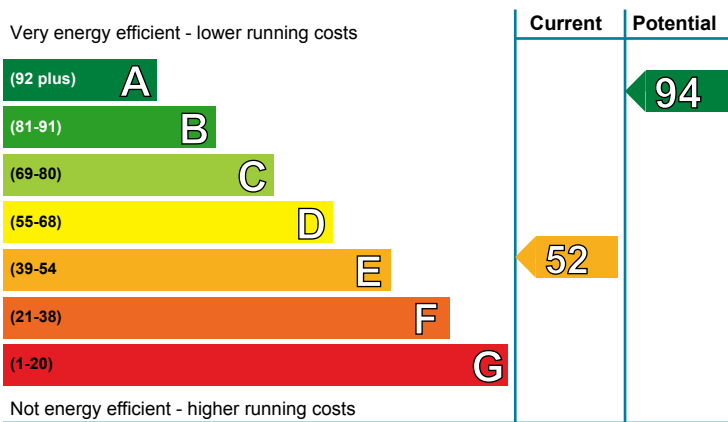
## Energy Efficiency Rating

This graph shows the current efficiency of your home, taking into account both energy efficiency and fuel costs. The higher this rating, the lower your fuel bills are likely to be.

Your current rating is **band E (52)**. The average rating for EPCs in Scotland is **band D (61)**.

The potential rating shows the effect of undertaking all of the improvement measures listed within your recommendations report.
