espc:home report

85 Victoria Street
Livingston
EH54 5BH
10/04/2024

Single Survey

Property address	85 Victoria Street, Craigshill, Livingston, EH54 5BH
-------------------------	---

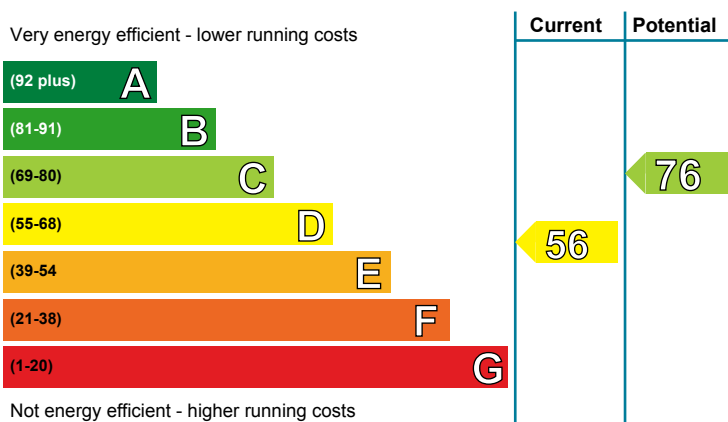
Energy Efficiency Rating

This graph shows the current efficiency of your home, taking into account both energy efficiency and fuel costs. The higher this rating, the lower your fuel bills are likely to be.

Your current rating is **band D (56)**. The average rating for EPCs in Scotland is **band D (61)**.

The potential rating shows the effect of undertaking all of the improvement measures listed within your recommendations report.
