# espc:home report

29 Glasgow Road  
Edinburgh  
EH12 8HW  
10/04/2024

# Single Survey

<b>Property address</b>	29 Glasgow Road, Corstorphine, Edinburgh, EH12 8HW
-------------------------	---

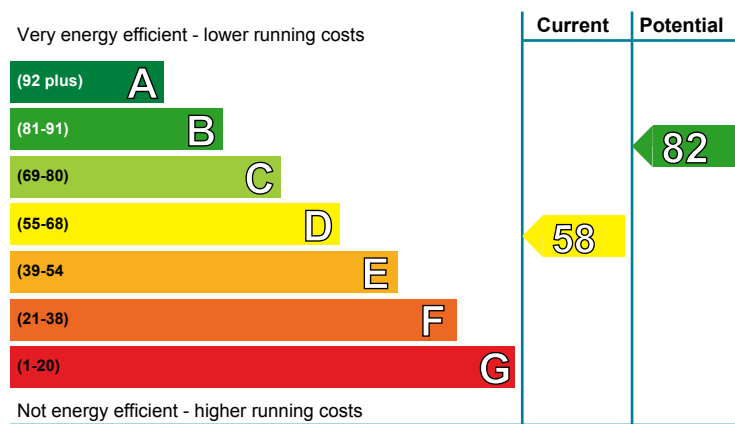
## Energy Efficiency Rating

This graph shows the current efficiency of your home, taking into account both energy efficiency and fuel costs. The higher this rating, the lower your fuel bills are likely to be.

Your current rating is **band D (58)**. The average rating for EPCs in Scotland is **band D (61)**.

The potential rating shows the effect of undertaking all of the improvement measures listed within your recommendations report.

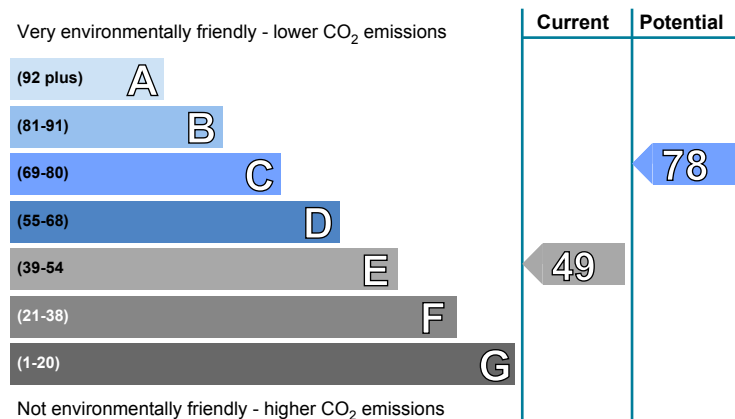
## Environmental Impact (CO<sub>2</sub>) Rating

This graph shows the effect of your home on the environment in terms of carbon dioxide (CO<sub>2</sub>) emissions. The higher the rating, the less impact it has on the environment.
