espc:home report

7 Falahill Cottages
Heriot
EH38 5YG
28/03/2024

Single Survey

Property address	Falahill Cottages, 7, Heriot, EH38 5YG
-------------------------	---

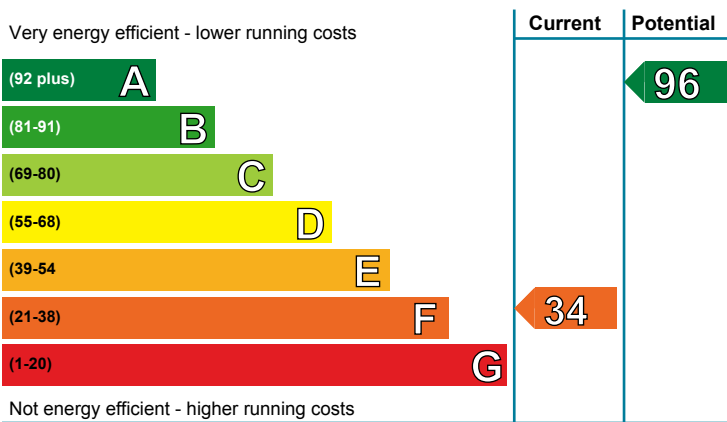
Energy Efficiency Rating

This graph shows the current efficiency of your home, taking into account both energy efficiency and fuel costs. The higher this rating, the lower your fuel bills are likely to be.

Your current rating is **band F (34)**. The average rating for EPCs in Scotland is **band D (61)**.

The potential rating shows the effect of undertaking all of the improvement measures listed within your recommendations report.
