espc:home report

10/3 Loganlea Gardens, Craigentenny
Edinburgh
EH7 6LH
15/04/2024

Single Survey

Property address	Flat 3, 10 Loganlea Gardens, Restalrig, Edinburgh, EH7 6LH
-------------------------	--

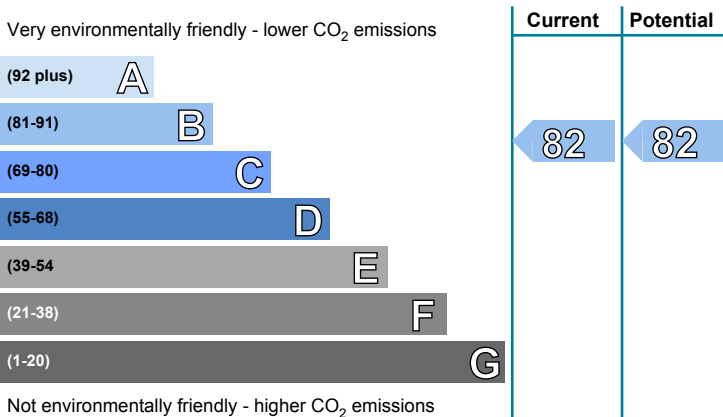
Environmental Impact (CO₂) Rating

This graph shows the effect of your home on the environment in terms of carbon dioxide (CO₂) emissions. The higher the rating, the less impact it has on the environment.
