SINGLE SURVEY REPORT

PROPERTY ADDRESS	4/1 Millar Place Edinburgh EH10 5HJ
CLIENT	Hussain
CLIENT ADDRESS	c/o Avenue Road Estate Agents
DATE OF INSPECTION	14 July 2021
PREPARED BY	DHKK Ltd Chartered Surveyors 54 Corstorphine Road Edinburgh EH12 6JQ Tel: 0131 313 0444 Fax: 0131 313 0555 Email: survey@dhkk.co.uk

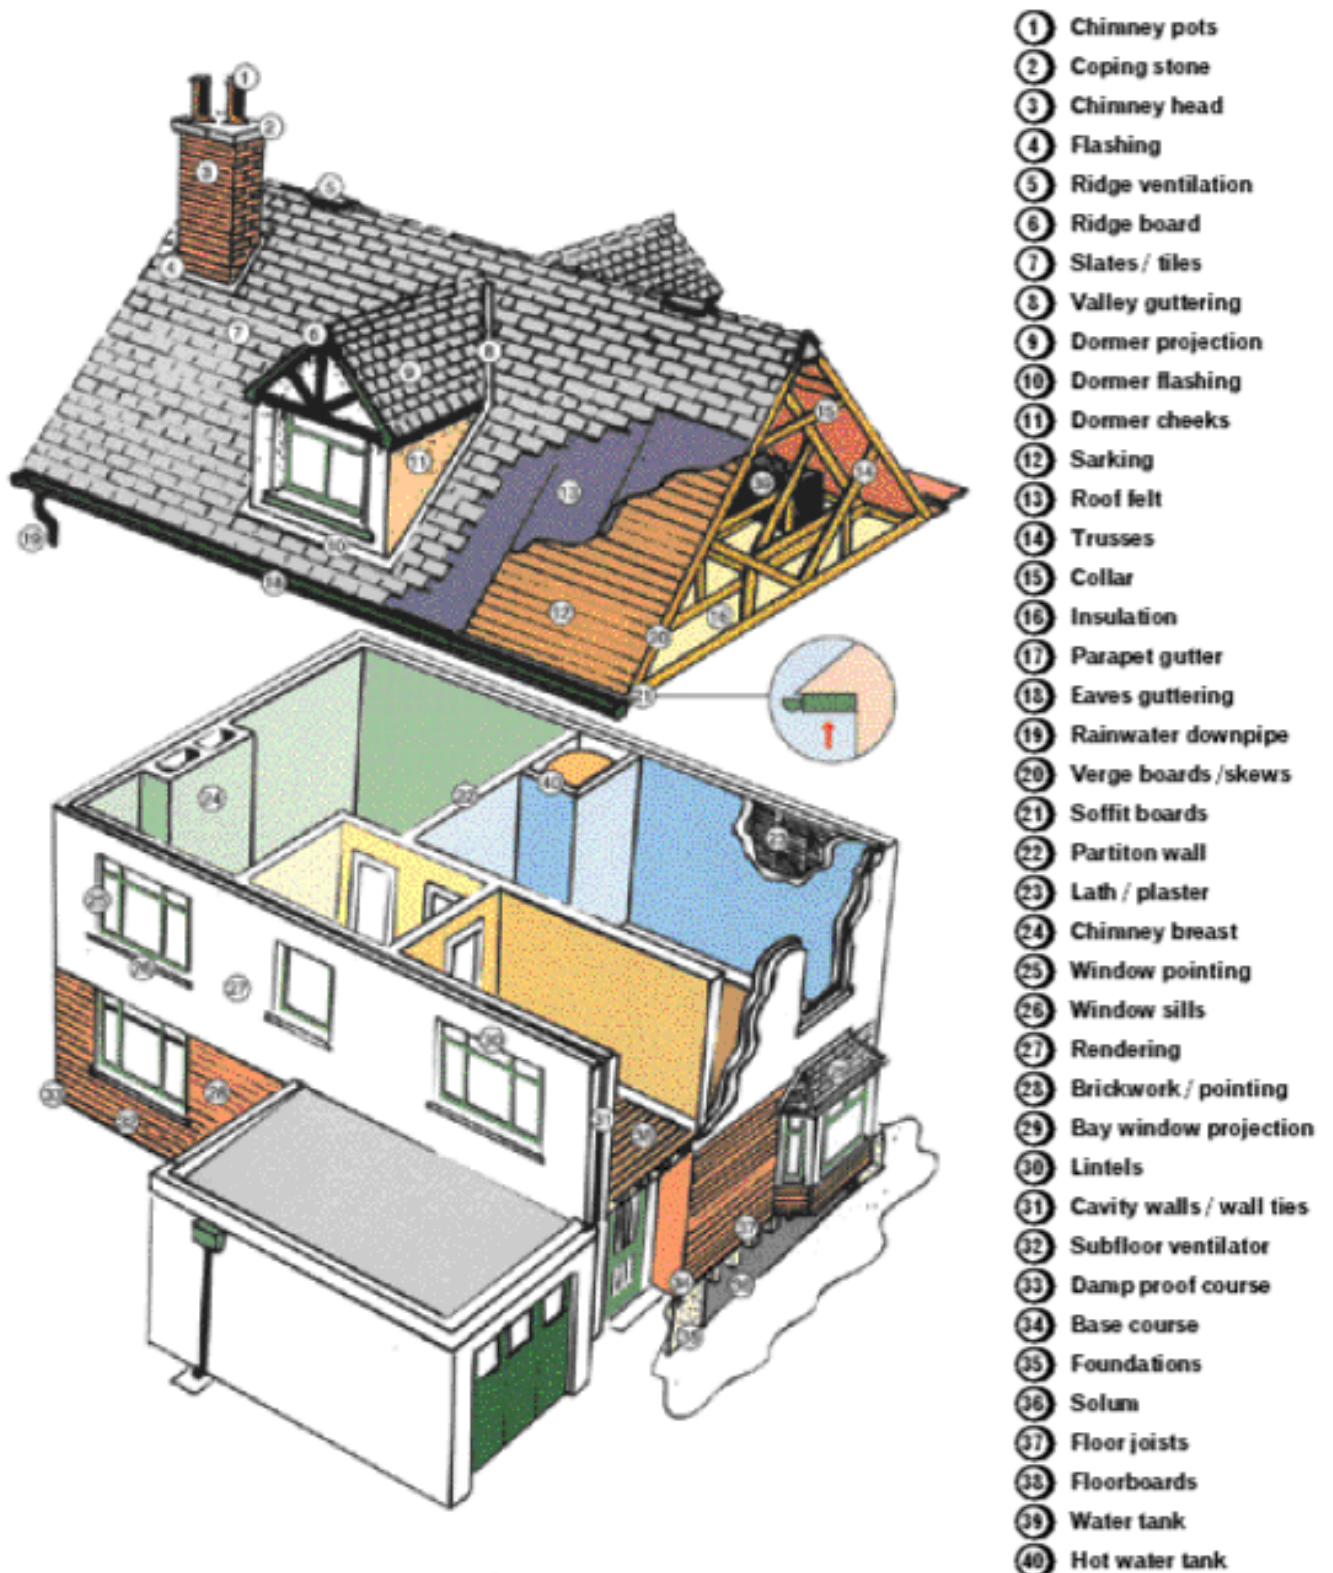
Sectional diagram showing elements of a typical house

- ① Chimney pots
- ② Coping stone
- ③ Chimney head
- ④ Flashing
- ⑤ Ridge ventilation
- ⑥ Ridge board
- ⑦ Slates / tiles
- ⑧ Valley guttering
- ⑨ Dormer projection
- ⑩ Dormer flashing
- ⑪ Dormer cheeks
- ⑫ Sarking
- ⑬ Roof felt
- ⑭ Trusses
- ⑮ Collar
- ⑯ Insulation
- ⑰ Parapet gutter
- ⑱ Eaves guttering
- ⑲ Rainwater downpipe
- ⑳ Verge boards /skews
- ㉑ Soffit boards
- ㉒ Partiton wall
- ㉓ Lath / plaster
- ㉔ Chimney breast
- ㉕ Window pointing
- ㉖ Window sills
- ㉗ Rendering
- ㉘ Brickwork / pointing
- ㉙ Bay window projection
- ㉚ Lintels
- ㉛ Cavity walls / wall ties
- ㉜ Subfloor ventilator
- ㉝ Damp proof course
- ㉞ Base course
- ㉟ Foundations
- ㊱ Solum
- ㊲ Floor joists
- ㊳ Floorboards
- ㊴ Water tank
- ㊵ Hot water tank

Reference may be made in this report to some or all of the above component parts of the property. This diagram may assist you in locating and understanding these terms.
