SINGLE SURVEY REPORT

PROPERTY ADDRESS	7 East Hermitage Place Edinburgh EH6 8AA
CLIENT	Mr J McCutcheon & Miss L Downie
CLIENT ADDRESS	7 East Hermitage Place Edinburgh EH6 8AA
DATE OF INSPECTION	4 th November 2021
PREPARED BY	DHKK Ltd Chartered Surveyors 54 Corstorphine Road Edinburgh EH12 6JQ Tel: 0131 313 0444 Fax: 0131 313 0555 Email: survey@dhkk.co.uk

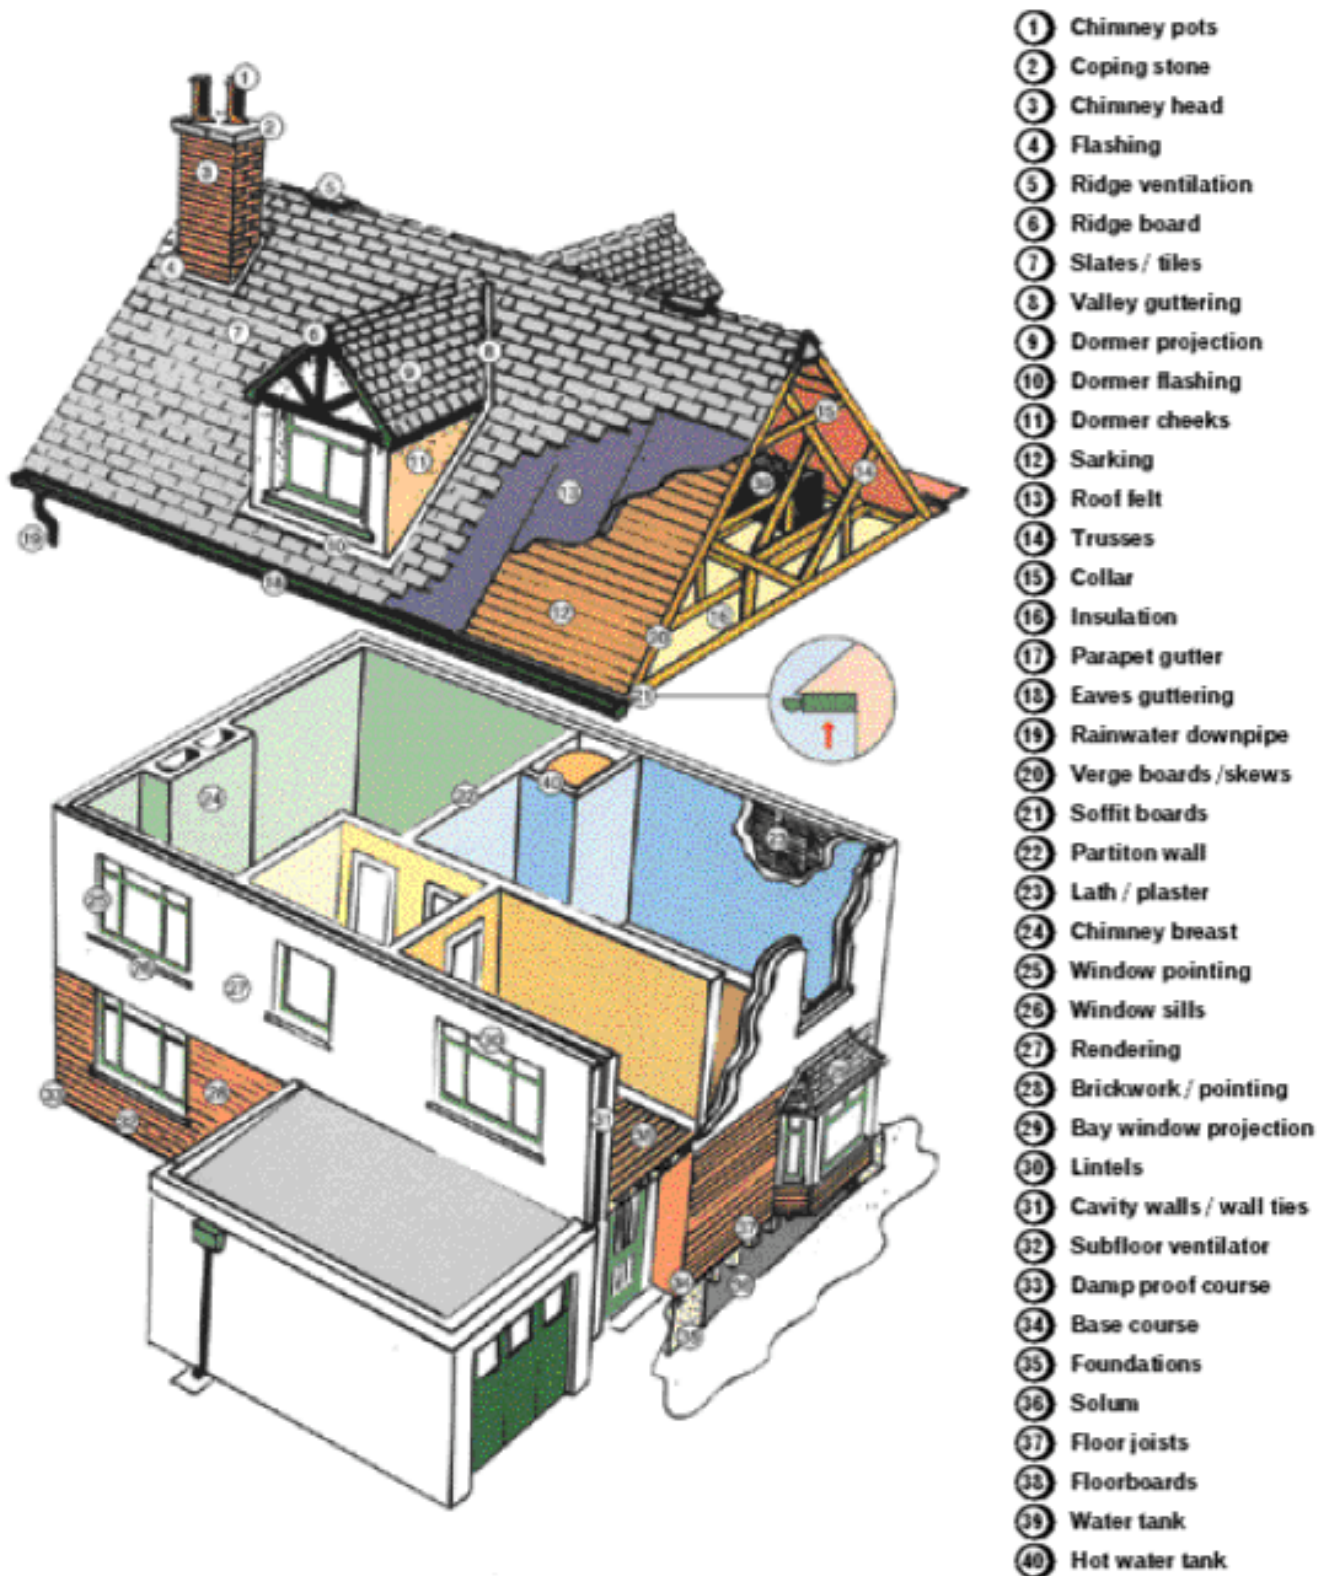
Sectional diagram showing elements of a typical house

- ① Chimney pots
- ② Coping stone
- ③ Chimney head
- ④ Flashing
- ⑤ Ridge ventilation
- ⑥ Ridge board
- ⑦ Slates / tiles
- ⑧ Valley guttering
- ⑨ Dormer projection
- ⑩ Dormer flashing
- ⑪ Dormer cheeks
- ⑫ Sarking
- ⑬ Roof felt
- ⑭ Trusses
- ⑮ Collar
- ⑯ Insulation
- ⑰ Parapet gutter
- ⑱ Eaves guttering
- ⑲ Rainwater downpipe
- ⑳ Verge boards /skews
- ㉑ Soffit boards
- ㉒ Partiton wall
- ㉓ Lath / plaster
- ㉔ Chimney breast
- ㉕ Window pointing
- ㉖ Window sills
- ㉗ Rendering
- ㉘ Brickwork / pointing
- ㉙ Bay window projection
- ㉚ Lintels
- ㉛ Cavity walls / wall ties
- ㉜ Subfloor ventilator
- ㉝ Damp proof course
- ㉞ Base course
- ㉟ Foundations
- ㊱ Solum
- ㊲ Floor joists
- ㊳ Floorboards
- ㊴ Water tank
- ㊵ Hot water tank

Reference may be made in this report to some or all of the above component parts of the property. This diagram may assist you in locating and understanding these terms.
