## **HOME REPORT**

19 OLIPHANT COURT  
STIRLING  
FK8 1US

# Energy Performance Certificate (EPC)

**19 OLIPHANT COURT, STIRLING, FK8 1US**

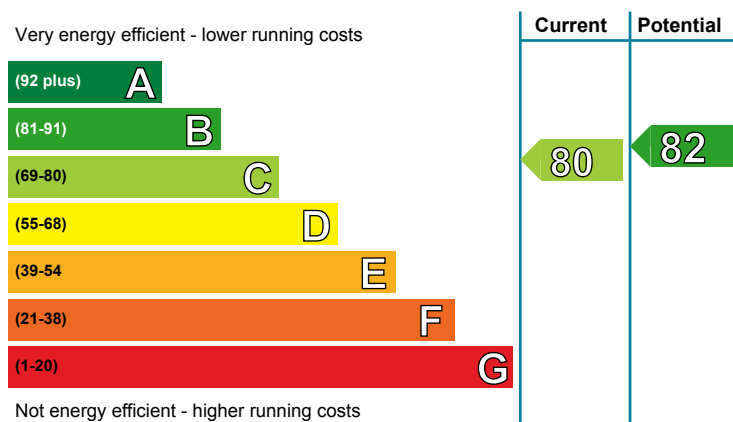
## Energy Efficiency Rating

This graph shows the current efficiency of your home, taking into account both energy efficiency and fuel costs. The higher this rating, the lower your fuel bills are likely to be.

Your current rating is **band C (80)**. The average rating for EPCs in Scotland is **band D (61)**.

The potential rating shows the effect of undertaking all of the improvement measures listed within your recommendations report.
