HOME
report

SINGLE SURVEY
ENERGY REPORT
PROPERTY QUESTIONNAIRE
VALUATION REPORT

Single Survey

| Property address | 22 Boreland Drive, Glasgow, G13 3DF |

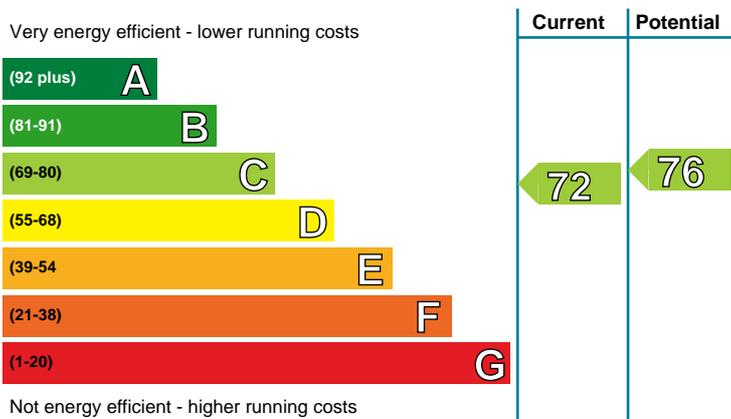
Energy Efficiency Rating

This graph shows the current efficiency of your home, taking into account both energy efficiency and fuel costs. The higher this rating, the lower your fuel bills are likely to be.

Your current rating is **band C (72)**. The average rating for EPCs in Scotland is **band D (61)**.

The potential rating shows the effect of undertaking all of the improvement measures listed within your recommendations report.

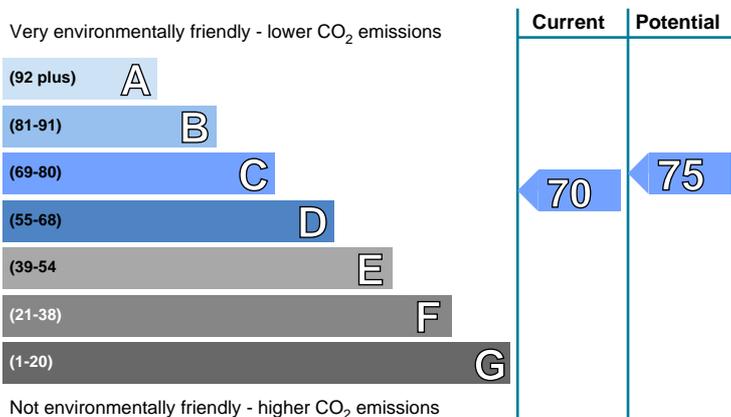
Environmental Impact (CO₂) Rating

This graph shows the effect of your home on the environment in terms of carbon dioxide (CO₂) emissions. The higher the rating, the less impact it has on the environment.
